# ETS-VIII Ion Engine and its Operation on Orbit

IEPC-2009-048

*Presented at the 31st International Electric Propulsion Conference,  
University of Michigan • Ann Arbor, Michigan • USA  
September 20 – 24, 2009*

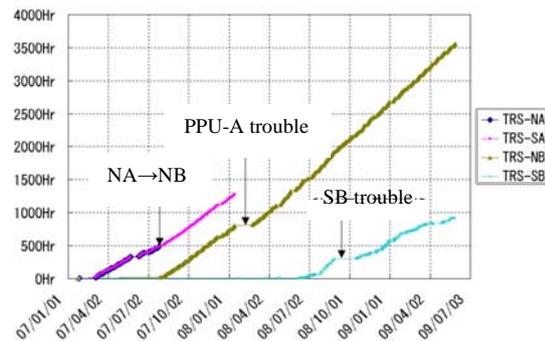
Figure 3 Cumulative Operation Time of Thrusters

IES was primarily tested in January 2007, approximately one month after the launch. And then NSSK by IES began in March 2007. Figure 3 indicates a history of accumulative operating time of each thruster.

The main discharge plasma sometimes disappeared off a primary thruster on the north panel (TRS-NA) during operations, and it caused some difficulties that required sending a restart command. So a thruster was switched to a secondary one on the north panel (TRS-NB) in July. Both north and south gimbals adjusted the thrust vectors towards the center of the satellite mass for primary thrusters, so only the north gimbals were adjusted again for TRS-NB.

After this change, NSSK was conducted by a primary south thruster (TRS-SA) at an ascend node and by TRS-NB at a descend node in orbit for a half year. However, TRS-SA did not start operating on January 15, 2008, and therefore NSSK by IES had to be halted for about two months.

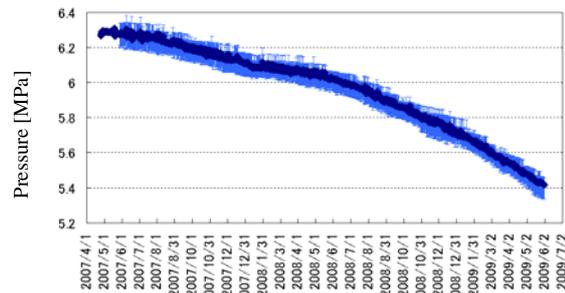
Figure 4 History of Propellant Tanks Pressure

Figure 4 and 5 show a history of the pressure of propellant tanks and the change in regulated pressure in the downstream of a regulator respectively.

The pressure of propellant tanks gradually decreased due to xenon consumption, as predicted. Also the regulated pressure during beam injection indicated a normal value, as previously planned.

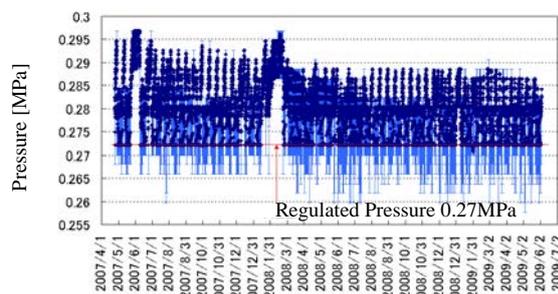
Figure 5 Change of Regulated Pressure

Figure 5 shows that a propellant management unit fed xenon flow under stable regulated pressure and Figure 6 shows that the temperature of FCM was relatively kept constant, so that a constant propellant feed could be conducted to a thruster during beam injection.

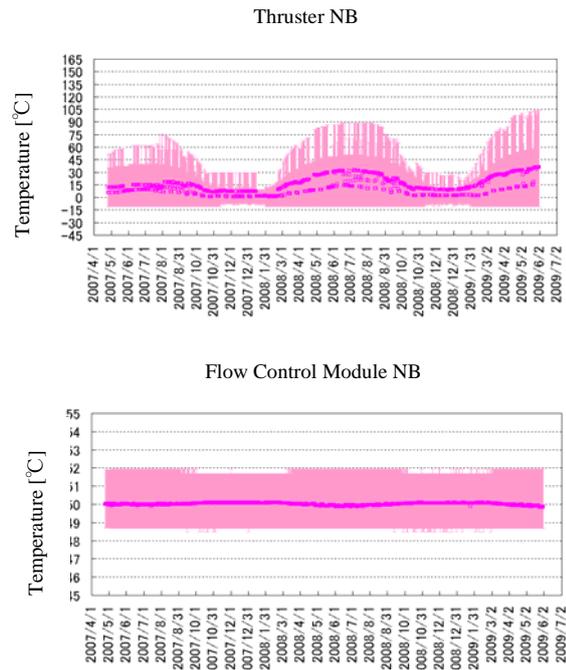
Figure 6 Temperatures at TRS-NB

Figure 6 shows the histories of temperatures at TRS-NB and a propellant flow control module (FCM) provided to this thruster, as examples of telemetry data. The temperature of the thruster which was installed on the outer panel of the satellite was affected by solar heat and by the satellite attitude, whereas that of FCM was quite stable as it was located inside of the satellite. Both sets of data agreed with the results of thermal analyses, and it was confirmed that there were enough margins for a thermal subsystem design.

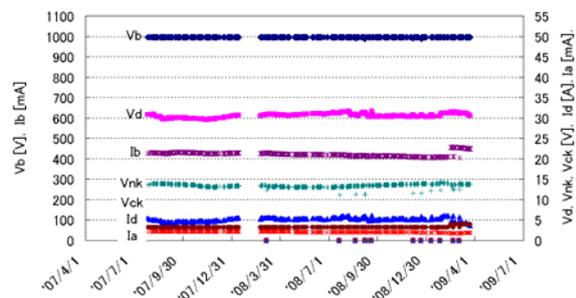
Figure 7 Telemetry Data of Currents and Voltages at TRS-NB

Figure 7 indicates the histories of current and voltage values at TRS-NB, measured by telemetry. And Figure 8 shows the change in TRS-NB thrust. The thrust gradually decreased from the beginning of the operation under the same conditions, and then it increased in January 2009 by changing operational parameters after it had fallen below 20mN. A decrease in thrust was considered as a change with a lapse of time, which was a similar change to that observed in ground tests.

Currents and voltages showed normal and stable values initially; afterwards these values varied with resetting operational conditions, but the variation was within expectations.

Low thrusting phenomena observed before 3500 hours of cumulative operating time were caused by a recovery operation for high voltage break downs (HVBD).
