The 25 cm XIPS[®] Life Test and Post-Test Analysis

IEPC-2009-161

William G. Tighe*, Kuei-Ru Chien†, Zeke Solis‡, and Rafael Spears§
L-3 Communications Electron Technologies, Inc., Torrance, CA, 90505

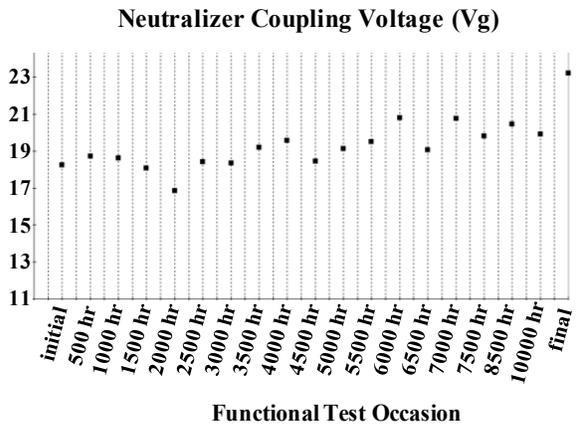
Also observed was a rise in the coupling voltage toward the end of the Low Power phase of the Life Test, most likely as a result of Neutralizer Keeper erosion.

There were a total of 19 functional tests performed during the low-power phase of the life test. All thruster parameters were within specification during all nineteen functional tests. Examples of Trend Plots and Functional Test Plots are shown in Figs. 8 to 11. The intentional change of the gas flow is indicated. The reason for this was to increase the discharge voltage to a “worst case” condition for wear of the Screen grid. In addition the steady increase in the Neutralizer Coupling Voltage (V_g) and the sudden increase in V_g on the last Functional Test Occasion was noted and felt to be due to erosion of the NCA Keeper and Orifice Plate.

Figure 10. Low Power Functional Test Results showing the Neutralizer Coupling Voltage.

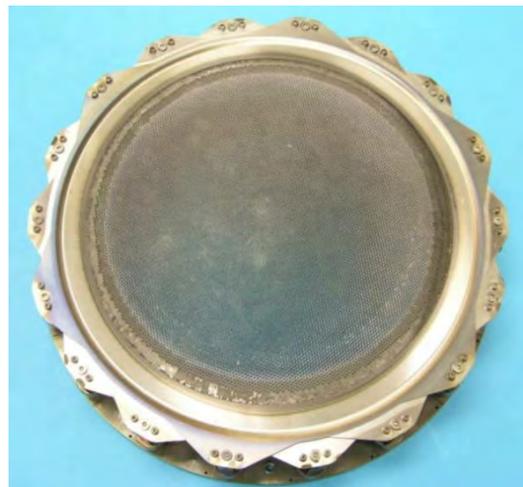
There has been clear enlargement of the Accel and Decel grid holes, particularly toward the outer radius. The Screen apertures have actually become smaller, presumably due to deposits. It was found that the Accel – Decel separation increased, possibly due to erosion, and the Screen – Accel separation decreased in the mid-radius region suggesting some distortion in the grid shape.

Figure 12. Overview of the Q2 Electrode Grid Set

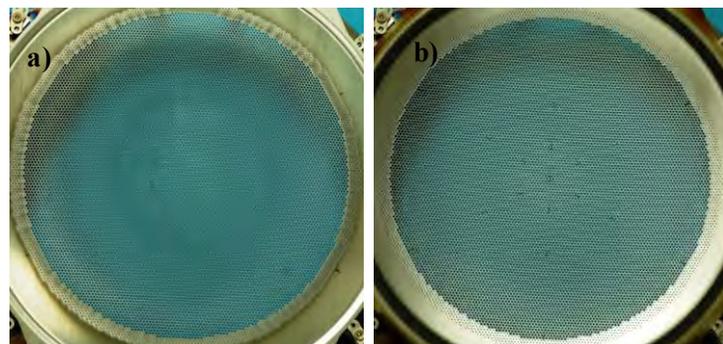
The presence of hexagonal grooves surrounding the apertures is clearly indicated on the upstream face of the grid. This is probably due to direct erosion of this surface from plasma ions and is similar to the "pits & grooves" erosion observed with the NSTAR thruster[7]. The downstream face is smooth.

Figure 14. Downstream (a) and upstream (b) face of the Q2 Screen Grid at the end of the Life Test.

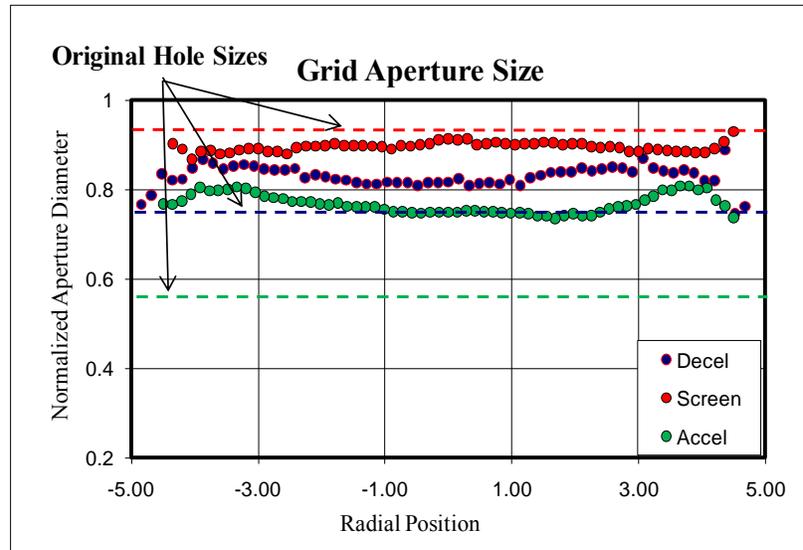
Figure 13. A plot of normalized aperture diameter for the Q2 Grid Set as measured prior to disassembly. Dashed lines indicate the original aperture diameter.

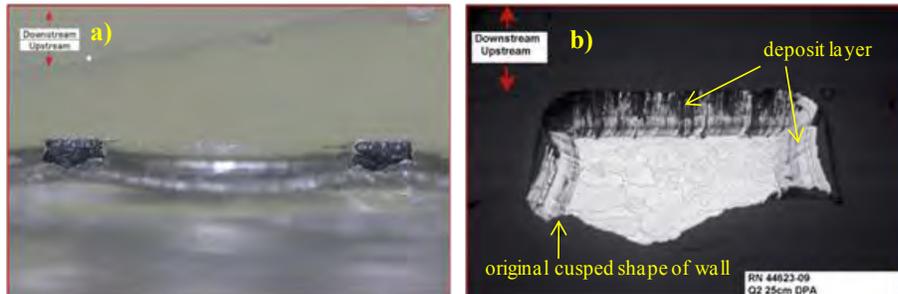
The Screen grid was then potted, sectioned and polished. Examples of optical and metallographic images are shown in Fig. 17. Significant erosion of the webbing was observed on the upstream face at the center of the grid. This reduced in a fairly linear manner toward the edge. The erosion at the center of the webbing was symmetric, increasing in the regions toward the aperture. From the half radius outward, there was some loss of symmetry to the erosion pattern.

On the edges and on the downstream face of the webbing, there is a significant and fairly uniform layer of deposit. Possibly due to this layer, there is little detectable erosion of the wall of the grid aperture. The original cusped shape of the aperture wall remains clear though eroded from the base of the upstream face.

Figure 17. Example of optical (a) and metallographic (b) images of the webbing structure at the aperture mid-plane, mid-radius in the Q2 Screen.

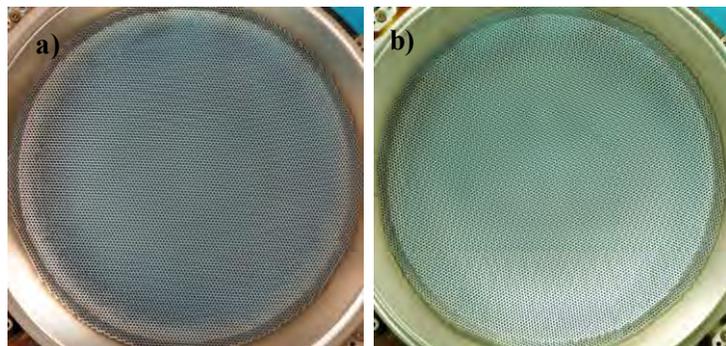
Photographs of the downstream face and the upstream (flipped) face of the Accel grid are shown in Fig. 18. A close-up photograph of a region of the Accel grid that showed some damage in a single aperture is shown in Fig. 19. This is approximately the same region shown for the Screen grid in Fig. 15. Aside from the damaged region, the photograph is fairly representative of the grid surface.

Figure 18. Downstream (a) and upstream (b) face of the Q2 Accel grid.

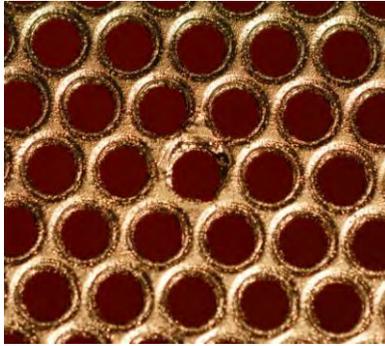
Figure 19. Close-up photo of the downstream face of the Accel grid showing a region of wear.

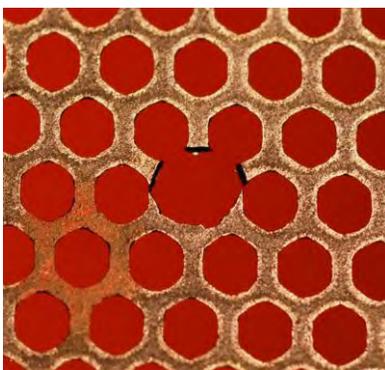
Figure 21. Close-up photo of the downstream face of the Decel grid showing a region of wear.

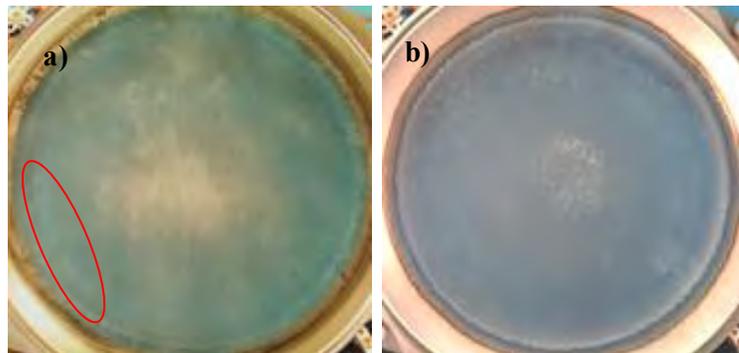
A region of erosion in the lower left corner (6 to 10 O'clock) of the Decel grid was apparent. This partial ring may indicate greater erosion toward the outer radius of the grid. A close-up photograph of a region of the Decel grid that showed loss of webbing in a single aperture is shown in Fig. 21. This is approximately the same region shown for the Screen

Figure 20. Downstream (a) and upstream (b) face of the Q2 Decel grid. An area of erosion (indicated in red) was noted.

As with the Screen grid, the potted, polished section of the Decel grid was then analyzed further using a Z-Scope. The erosion pattern of the Decel grid is presently being carefully analyzed. It is likely that changes in beam focusing due to ion density variations across the grid play a dominant role in the observed erosion pattern. Further work is being undertaken to evaluate this.

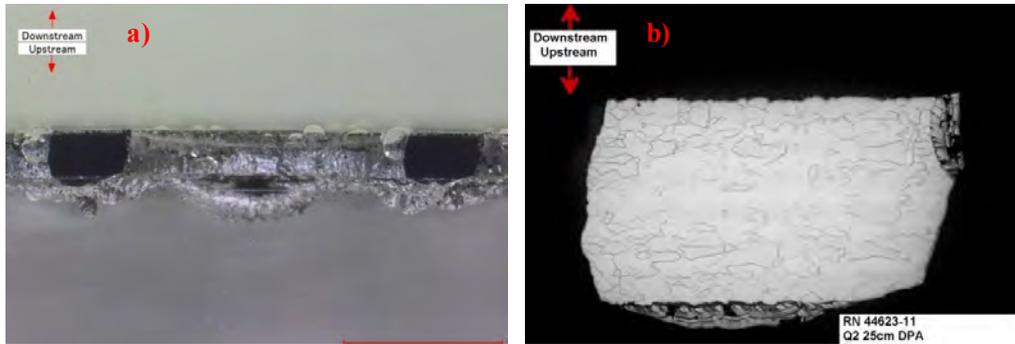
Optical and metallographic images are shown in Fig. 22. There was little change in the grid thickness across the radius. There was a loss of webbing width and, therefore, aperture enlargement across the radius. Analysis has shown that this aperture enlargement increases outward from mid-radius. On the upstream face of the webbing, there was a layer of deposit that became thickest at mid-radius. The erosion of the hole wall was quite uniform in the center with most of the original cusped wall shape (due to the manufacturing process) being lost. At the mid-radius there was greater erosion of the hole wall and there is some asymmetry. At the edge the erosion pattern was very non-symmetric with the cusp feature untouched in the direction of the outside wall but on the other side there was a strongly angled erosion pattern that may reflect the path of beam ions.

Figure 22. Example of optical (a) and metallographic (b) images of the webbing structure at the aperture mid-plane of the Q2 Screen Grid.

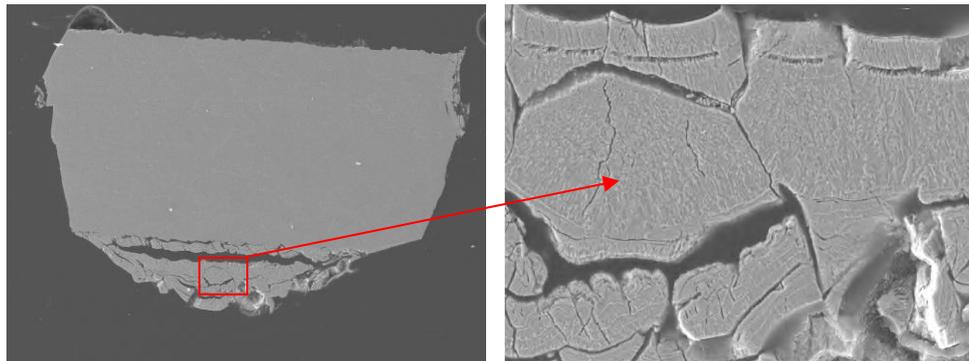
Finally a small section of the potted section was removed and used to obtain SEM images and elemental analysis of the grid and the deposit using EDS spectroscopy. The SEM images are shown in Fig. 23. EDS analysis showed that the deposit consisted solely of molybdenum that presumably originated from erosion of the Accel grid.

Figure 23. Low (left) and high (right) magnification SEM images of the deposit layer on the Q2 Decel Grid.

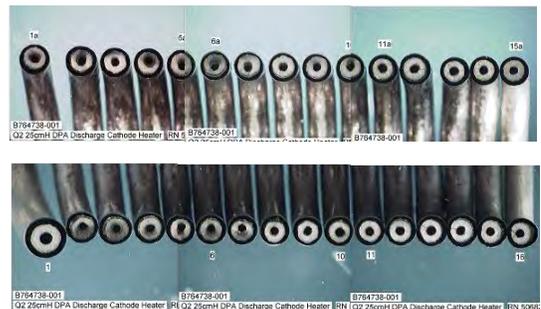
The heater was then potted in epoxy and sectioned to allow further analysis of the interior through optical (Fig. 24) and metallographic images. Though some deterioration of the heater was apparent through minor discoloration of the MgO insulator, the heater was in very good condition.

The metallographic images show changes but no dangerous deterioration of the heater. There was some formation of tantalates and migration of tantalum into the MgO. A single coil (shown in Fig. 25) at the output end showed intrusion of the MgO into the outer conductor. While

Figure 24. Optical images of the cross-sectioned DCA heater.

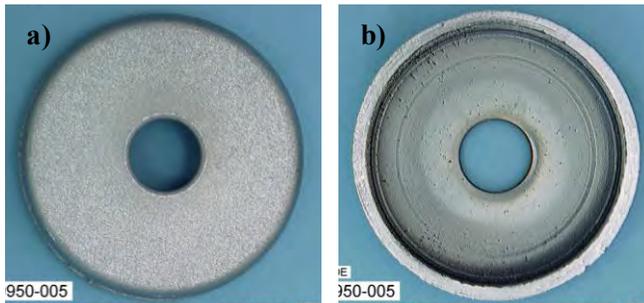
The Discharge Cathode Keeper was carefully removed, visually inspected and photographed. The End Cap was cut off so that any erosion effects on the end of the Keeper could be determined. Optical photographs of the Keeper End Cap are shown in Fig. 26. The original shiny appearance of the front of the Keeper End Cap has been abraded possibly due to plasma etching. Some minor discoloration and the presence of small black particles were noted on the backside of the Keeper End Cap.

Figure 26. Photos of the front (a) and back (b) faces of the Q2 DCA Keeper End Cap.

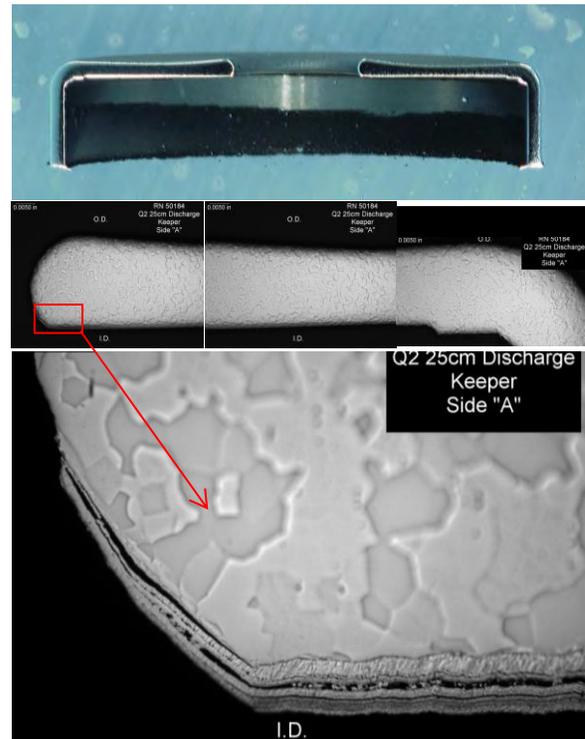
The Keeper End Cap was then potted, sectioned and polished. Optical and metallographic images of this cross-section are shown in Fig. 27. In this figure, 3 metallographic images have been placed side-by-side to create a complete image of the right side of the cross-sectioned Cap. Both this and the optical image show that only a moderate amount of erosion of the Keeper Face occurred. There is a

Figure 27. Optical (above) and Metallographic images of the cross-sectioned Q2 DCA Keeper Cap

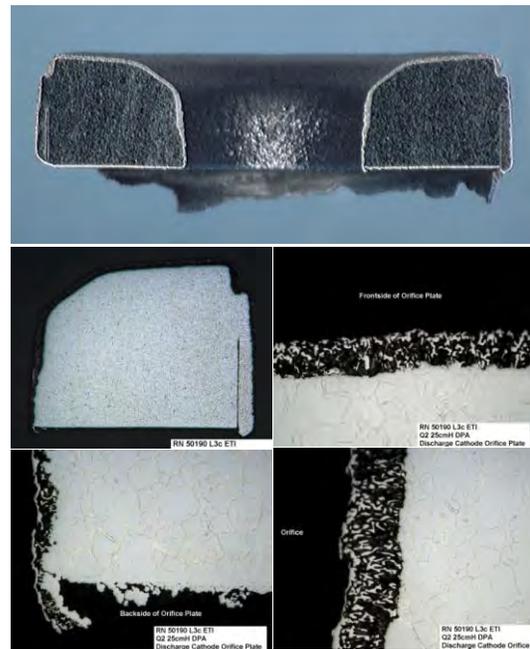
The orifice plate aperture diameter was basically unchanged while erosion of the face reduced the thickness at the center by ~ 15% near the start of the original tapered portion of the orifice.

Figure 29. Optical (upper) and Metallographic images of the cross-sectioned Q2 DCA Orifice Plate

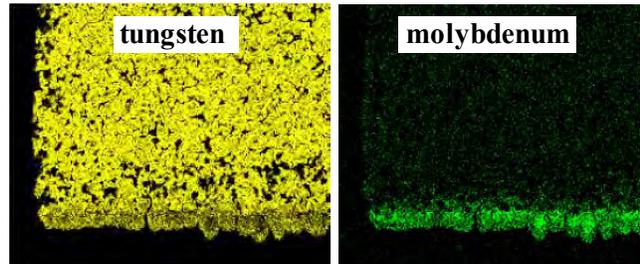
With lower resolution SEM images there appears to be a greater amount of dark (open) pores in the downstream end, both on the front face and toward the inner diameter. In addition, in this front location, at the inner diameter edge, there appears to be a region of denser material. An elemental map (Fig. 33) of this area indicates that this region contains molybdenum. The source of this molybdenum (also noted with EDS data taken on the unpolished inner diameter surface) is likely to be the front face of the orifice plate where preferential loss of the molybdenum was observed. The molybdenum could be incorporated into the plasma that exists in this region during operation and subsequently diffuse into this part of the insert.

Figure 33. Elemental map of at the exit region of the insert showing the molybdenum layer on the inner surface.

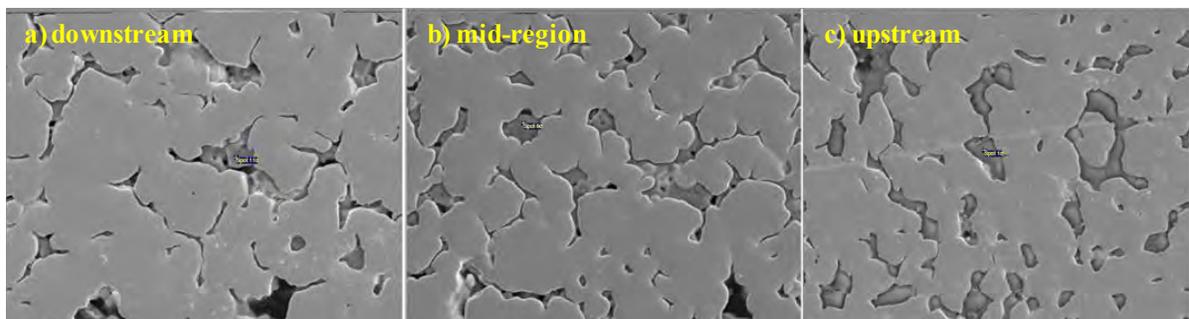
High resolution SEM images, shown in Fig. 34, show the changes to the contents of the pores in regions, taken closest to the insert inner diameter, at the downstream (a), middle (b) and upstream (c) locations. The EDS data was obtained at 11 axial locations along the mid-radius and in 5 radial locations in the downstream, middle and upstream locations. Of the more than 23 pores examined, the only significant change in elemental content was found in the pore examined in the front, inner diameter region. Here the barium level had dropped from a typical level by $\sim 25\%$, while the calcium level dropped to the noise level.

Figure 34. High resolution SEM images used in performing pore analysis in both axial and radial directions of the cross-sectioned Q2 DCA Insert.

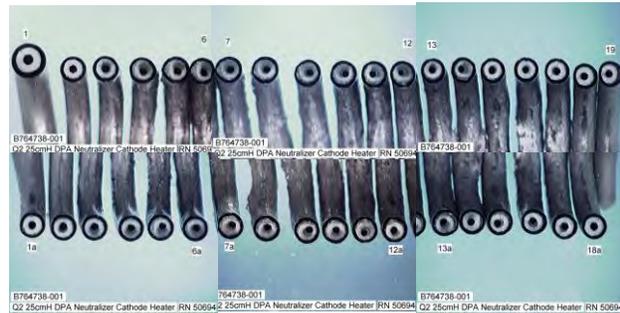
The heater was then potted in epoxy, sectioned, and polished. Optical (Fig. 36) and metallographic (Fig. 37) images were taken. Though some deterioration of the heater was apparent through minor discoloration of the MgO insulator, the heater appeared to be in good condition.

Figure 36. Optical image of cross-sectioned Q2 NCA heater.

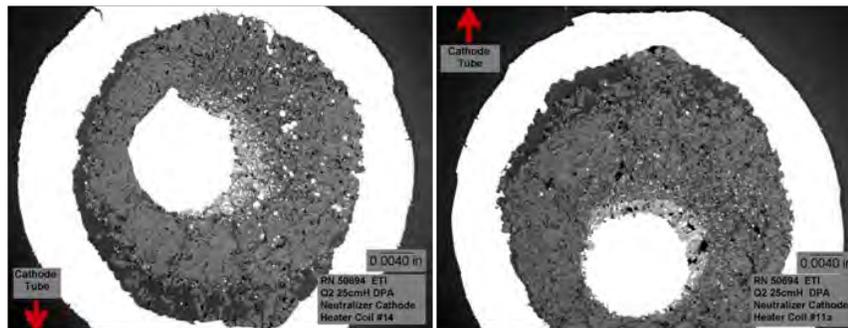
In a few coils the metallographic images showed a significant formation of tantalates and migration of tantalum into the MgO. There was some degree of tantalate formation in almost every coil, generally as a ring, or partial ring, around the inner conductor. Although MgO had penetrated into the outer conductor in many coils, wall material was not reduced to the point of a potential failure. In general the heater appeared to be in good to fair condition.

Figure 37. Metallographic images of the Q2 NCA Heater Coil cross-section.

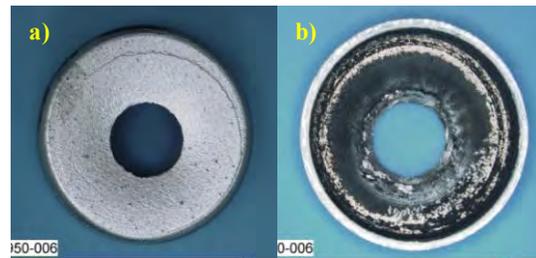
Upon inspection of the Q2 thruster following the completion of the Life Test, it was immediately noted that a region surrounding the NCA Keeper End Cap orifice consisted of thin, flaky material. Ultimately, the flaky material was lost.

The Neutralizer Cathode Keeper was carefully removed, visually inspected and photographed. The end cap was cut off so that any erosion effects on the end of the Keeper could be determined. Optical photographs of the Keeper and its Cap are shown in Fig. 38. The original shiny appearance of the front of the Keeper End Cap has been abraded due to plasma etching. The Keeper orifice has been significantly enlarged due to erosion and there is a large curved blemish seen in the upper portion of the front of the End Cap. The inside of the Keeper End Cap shows the several bands of discoloration and apparent deposition.

Figure 38. Photos of the front (a) and back (b) faces of the Q2 NCA Keeper End Cap.

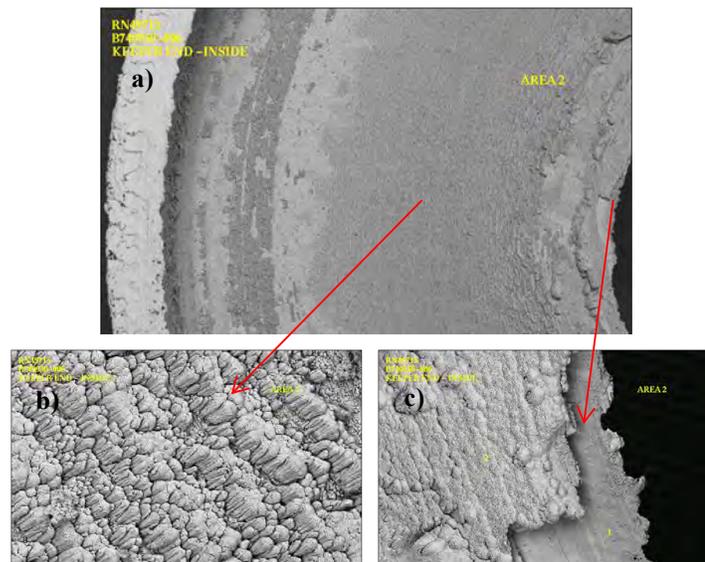
The back face or inside “upstream” surface of the Keeper End Cap was then documented in a similar manner. Typical SEM images are provided in Fig. 40. These images indicate some deposition

Figure 40. Low (a) and high (b & c) magnification SEM images showing deposit and orifice edge on the back face of the Q2 NCA Keeper.

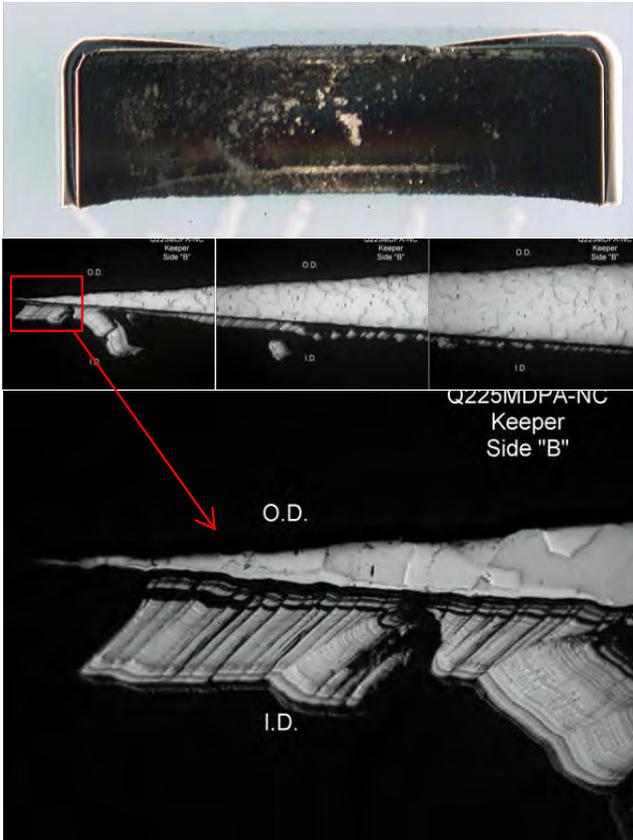
The Keeper aperture diameter approximately doubled in size while the thickness of the End Plate reduced by a third on the outside to a “knife-edge” at the orifice.

Figure 41. Optical (above) and Metallographic images of the cross-sectioned Q2 NCA Keeper Cap

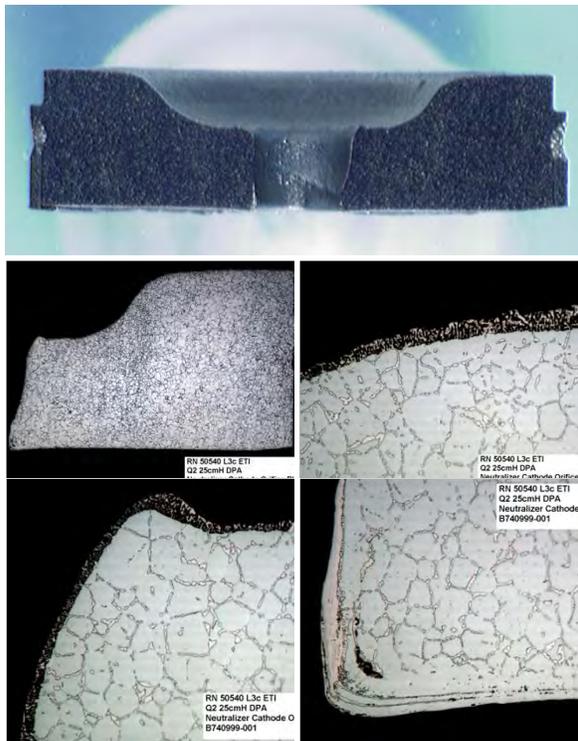
The original orifice plate aperture had straight walls. It has now become significantly dished on the downstream side. On the upstream side the orifice plate aperture diameter has not changed but on the downstream end the maximum diameter of the dished region has more than tripled. At the base of the dish, the orifice plate has thinned to approximately half of its original thickness.

Figure 44. Optical (upper) and Metallographic images of the aperture side wall, and higher magnification images of the top surface, and the upper and lower portions of the side wall of the cross-sectioned Q2 DCA Orifice Plate.

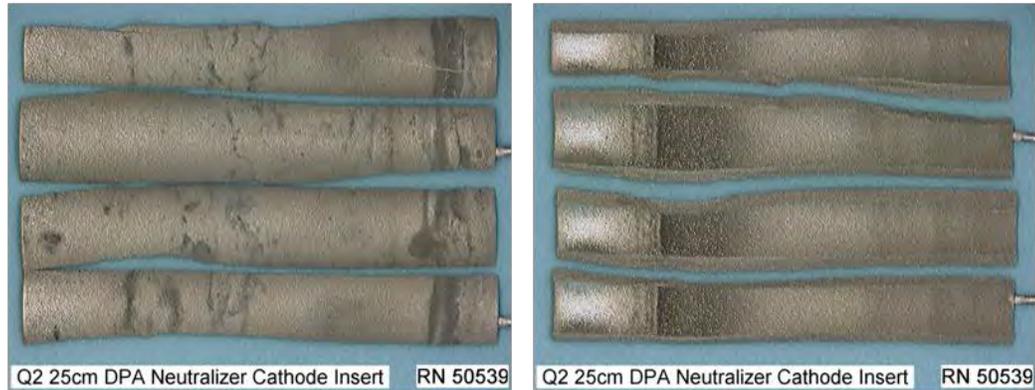
Optical photographs are shown in Fig. 45. The outside surfaces show signs of scoring possibly due to adherence to the cathode tube and caused during removal of the insert. The inside surface consists of several bands or regions.

Figure 45. Outer (a) and inner (b) photographs of the Q2 NCA hollow cathode insert after intentional fracturing for DPA.

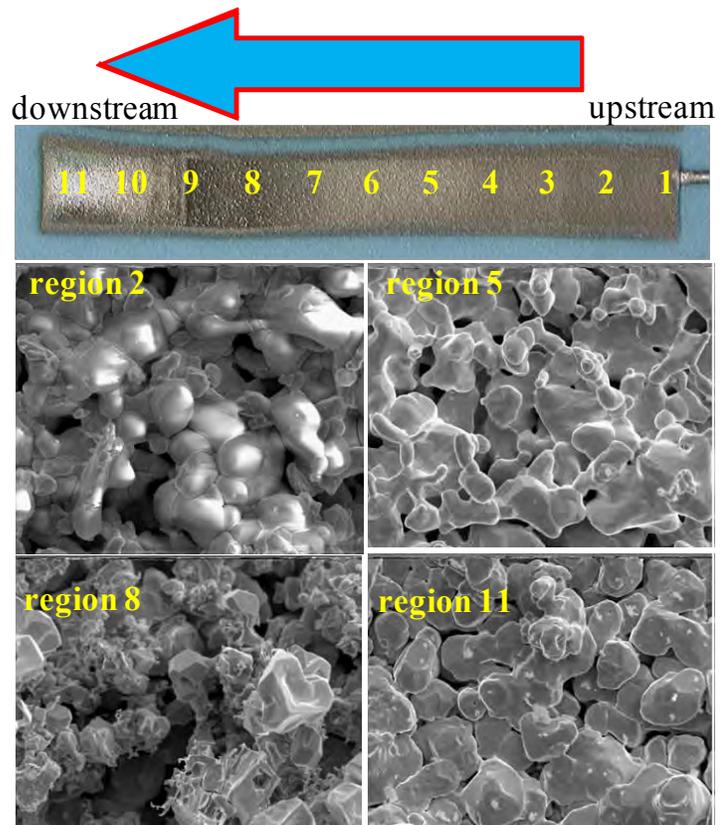
In the upstream location (regions 1 and 2) the SEM photographs show little or no change from a non-operated insert. In regions 3 and 4 the barium content has reduced but from region 5 to 11 there is little or no indication of barium on the surface. As with the DCA insert, molybdenum is detected in the

Figure 46. Regions of inner diameter of Q2 NCA insert that underwent SEM/EDS analysis and SEM images from specified regions.

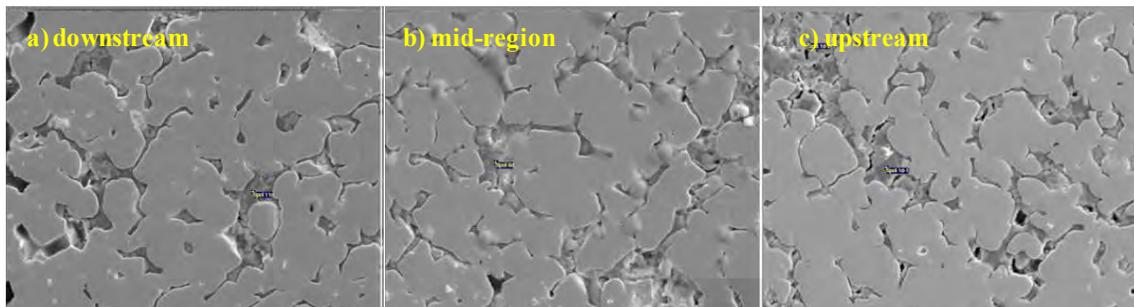
High resolution SEM images, shown in Fig. 48, show the changes to the contents of the pores in regions, taken closest to the insert inner diameter, at the front (a) downstream, middle (b) and rear (c) upstream locations. Of the more than 23 pores examined, the only significant change in elemental content was found in the pore in the region closest to the downstream end of the insert and closest to the inner diameter. The barium level in this region dropped $\sim 40\%$ while the calcium level dropped to the noise level.

Figure 48. High resolution SEM images used in performing pore analysis in both axial and radial directions of the cross-sectioned Q2 NCA Insert.
