# Results of a 35-cm Xenon Ion Thruster Endurance Test<sup>\*†</sup>

IEPC-01-083

**An endurance test of a 35-cm xenon ion thruster aiming at 5,000-hour operation was conducted to evaluate the thruster grid life and to find out weak points in the thruster endurance. In April 2001, the total operation time reached 4,994 hours. The ion production cost was almost constant at about 120 W/A in the first half of the test, but increased to about 130 W/A in the second half. The highest temperature of the discharge chamber magnets was raised along with this increase. Thruster disassembly and inspection after the test revealed several eroded parts in the thruster. Grid mass measurements indicated that the screen grid mass was almost unchanged, but that the accelerator and decelerator grids suffered mass loss. Back-sputtering from the ion beam target lowered the accuracy in the measurement. However, rough estimation from the mass loss rate showed that the accelerator grid would endure longer than 20,000 hours.**

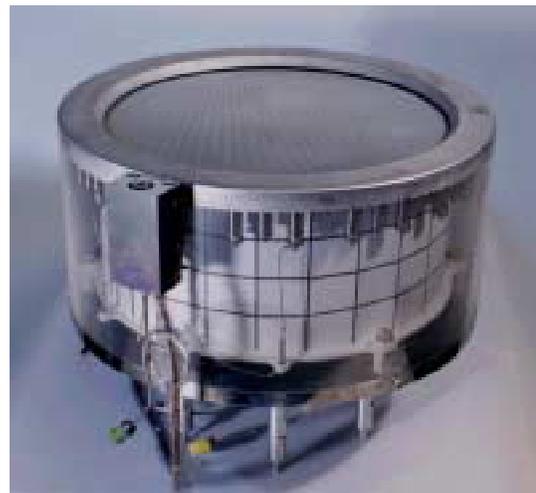
Figure 2 - Photograph of BBM-2 thruster.

Figures 1 and 2 show a cross-sectional view and a photograph of the thruster, respectively.

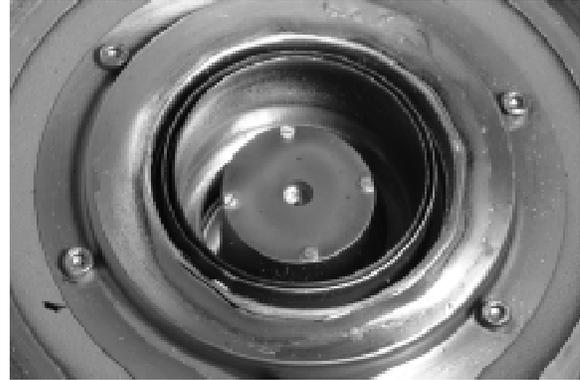
A crack was found on the magnet cover, as shown in Figure 5, which was installed over the magnet ring M4 for discharge current bypassing. The crack was located along the cusp lines on the magnet ring. A part of the crack penetrated the entire thickness of the cover made of molybdenum.

Figure 5 - Photograph of cracked magnet cover.

The temperature of the magnet ring M4 exceeded 200 EC after about 3,300 hours, and the magnet cover for the magnet ring M4 suffered cracking. These have caused concern about magnet degradation. However, measurements on the magnet degradation have not been conducted yet, but only a simple check was done. A piece of iron attracted by the magnets was pulled away by hand. No noticeable changes were found in the pulling forces compared with normal magnets. Efforts to keep the low levels of ion production cost would be necessary to prevent possible magnet degradation in much longer operation.
