Endurance Tests of Graphite Orificed Hollow Cathodes

IEPC-2009-022

*Presented at the 31st International Electric Propulsion Conference,
University of Michigan • Ann Arbor, Michigan • USA
September 20 – 24, 2009*

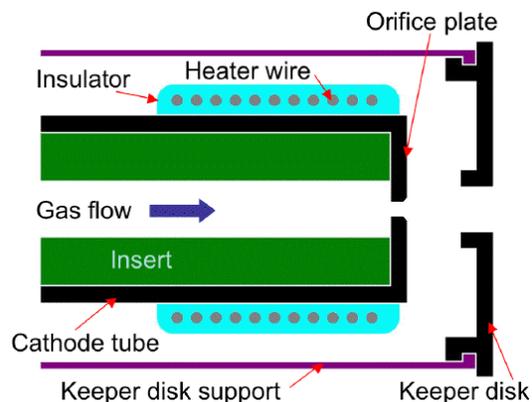
Figure 1 shows a schematic of a graphite orificed hollow cathode⁷ in which the keeper disk, orifice plate, and cathode tube are made of high density graphite. The orifice plate and cathode tube form a single piece as shown in Fig. 1, while the cathode insert is composed of porous tungsten impregnated with a mixture of barium oxide, calcium oxide, and aluminum oxide.

Figure 1. Schematic of graphite orificed hollow cathode. Black colored parts (keeper disk, orifice plate, and cathode tube) are made of graphite.

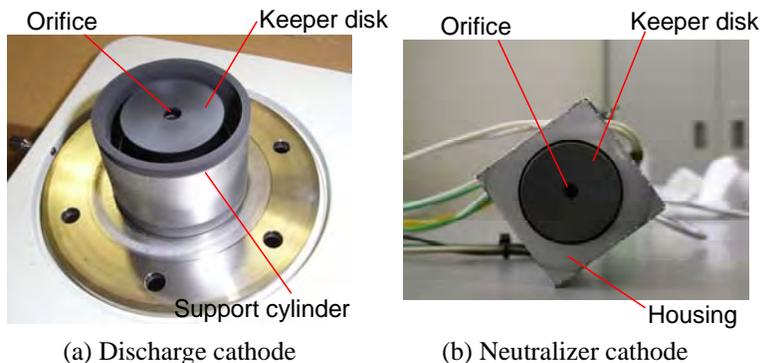
Figure 2 shows the graphite orificed hollow cathodes developed for main discharge and beam neutralization. The discharge cathode incorporates a support cylinder, the tip of which is made of graphite to avoid erosion problems. The design maximum emission currents of the discharge and neutralizer cathodes are 21 A and 4 A, respectively.

Figure 2. Photograph of graphite orificed hollow cathodes. (a) Discharge cathode, (b) Neutralizer cathode.

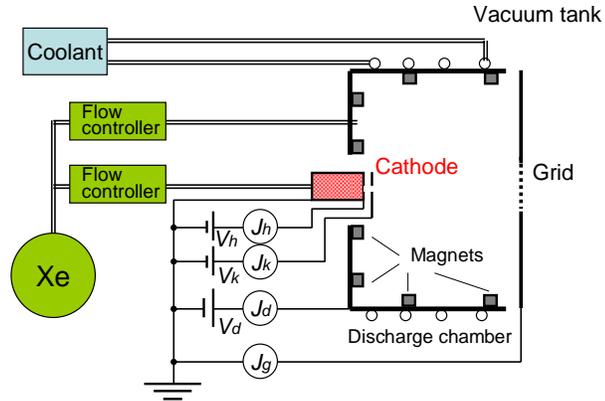
Figure 3 shows a schematic of the test apparatus. The cathode is operated in a discharge chamber⁸ to simulate thruster operating conditions. The geometrical and magnetic configurations of the discharge chamber are almost the same as those of the actual thruster. The temperature around the xenon flow controllers is kept constant by Peltier cooling and heating in order to avoid flow fluctuation due to temperature variation. Currents and voltages are sampled automatically at one-minute intervals by a data acquisition system. If an abnormal pressure or temperature condition is detected, cathode operation is halted automatically. The tank pressure

Figure 3. Test apparatus for discharge cathode endurance test.

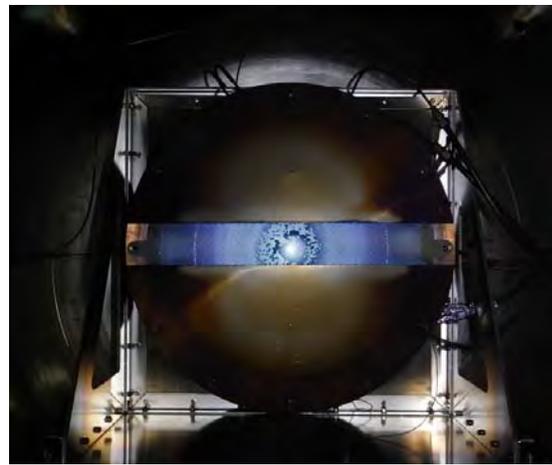
A front view of the discharge chamber during operation is shown in Fig. 4. The gridded area is restricted to a horizontal band to reduce xenon consumption.

Figure 4. Front view of discharge chamber during cathode operation. Discharge luminescence is visible through band-shaped grid area.

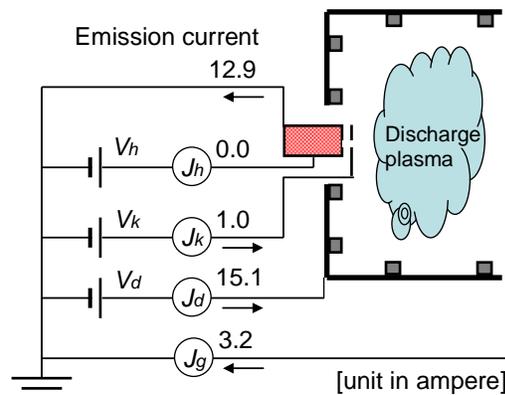
Figure 5 shows the electrical current distribution for the conditions shown in Table 1. Because the grid current of 3.2 A is derived from ion production in the discharge chamber, the electron emission current from the cathode is 12.9 A.

Figure 5. Current distribution in nominal operation.

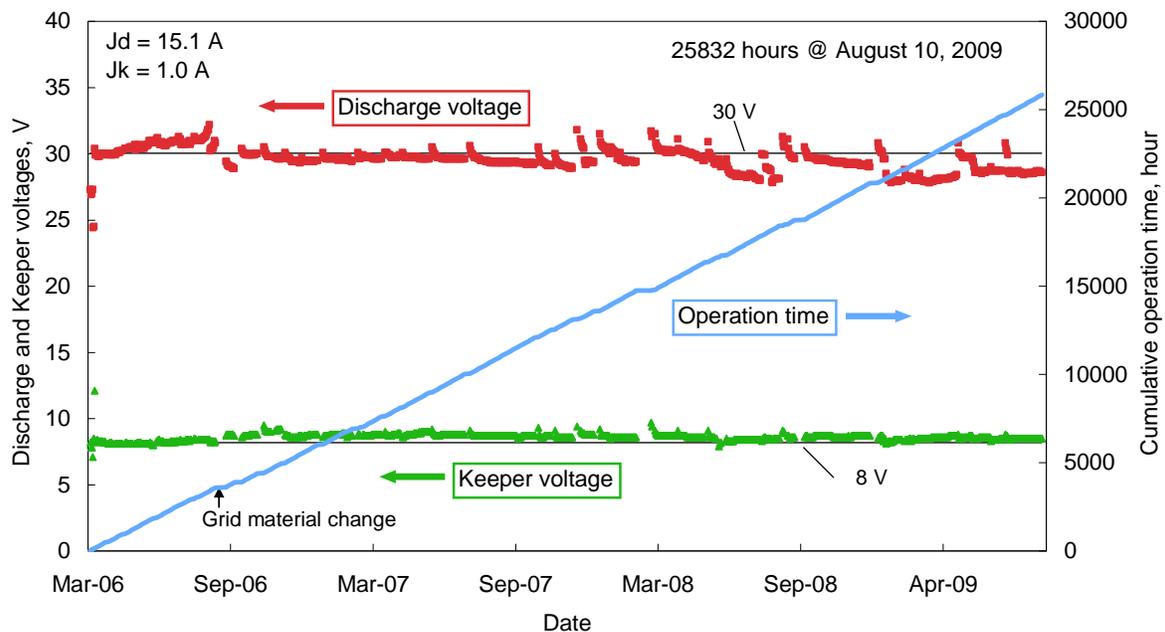
The discharge cathode endurance test was started in March 2006. The cumulative operation time and voltage variations during the test are shown in Fig. 6. The test had accumulated 25,800 hours of operation as of August 2009 and is still in progress. The rate of operation has been approximately 85%. The test has been interrupted approximately 50 times so far, 80% of these interruptions being intentional and 20% accidental. The most important event so far has been a change in the grid material from stainless steel to molybdenum in August 2006.⁹ Since this event, there have been no modifications to the test apparatus.

Figure 6 indicates that the discharge and keeper voltages have been almost stable at approximately 30 V and 8 V, respectively, throughout the test and there have been no gradual voltage increases due to cathode deterioration. The glitches in the voltages are caused by transient phenomena in which the voltages rise for a short interval after ignition sequences as described later.

Although voltage variations have not been large so far, the discharge voltage behavior is different before and after the grid exchange in August 2006. Before this event, the discharge voltage had been rising gradually for 5 months from 30 to 32 V. The reason for this trend was an increase in the gas conductance of the stainless steel grid

Figure 6. Discharge and keeper voltages and cumulative operation time in endurance test of discharge cathode from March 2006 to August 2009.

due to erosion.⁹ The grid was therefore exchanged with one made of molybdenum. After the exchange, the discharge voltage became stable or rather showed a decreasing trend as shown in Fig. 6. This decreasing trend can be explained by examining the close-up front view of the grid shown in Fig. 7, taken in July 2009. Some grid apertures around the central area have become filled with material and the ratio of the filled area to the total perforated area is approximately 8%. This deposition caused an 8% decrease in gas conductance and increased gas pressure in the discharge chamber, leading to a reduced discharge voltage. The nature of the deposited material is unknown at present and analysis

The keeper voltage has been fairly stable as shown in Fig. 6, and there have been no signs of cathode degradation such as depletion or contamination of the impregnated insert. Microscopic examinations of the electrodes in October 2006 and December 2007 revealed that the diameter of the orifice had increased by approximately 10% during the first several thousand hours of operation, but subsequent enlargement has been negligible.⁹ This result might indicate that the shape of the orifice became adapted to the operating conditions after several thousand hours and this change was completed in the early stage of the endurance test.

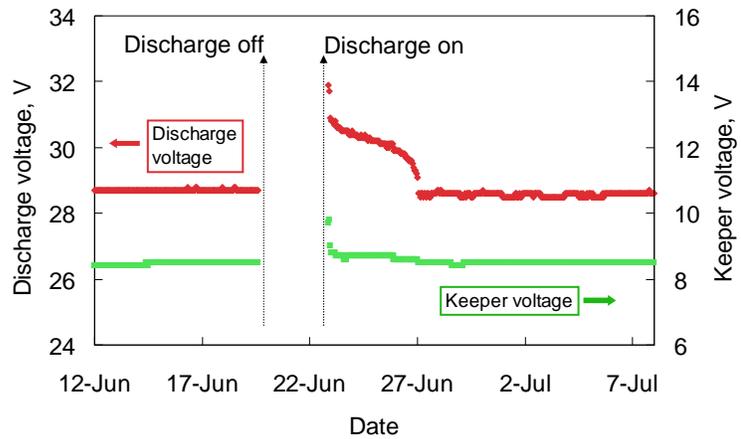
Figure 8 shows the short-term variations of the discharge and keeper voltages before and after ignition. The voltages rise just after ignition but return to their previous values approximately 100 hours after. This transient phenomenon is the reason for the glitches shown in Fig. 6. In this case, the test support apparatus was shut down during the interruption due to a scheduled power outage and the tank pressure rose to several tens of Pascals

Figure 8. Short-term variations of discharge and keeper voltages before and after ignition from June to July 2009.

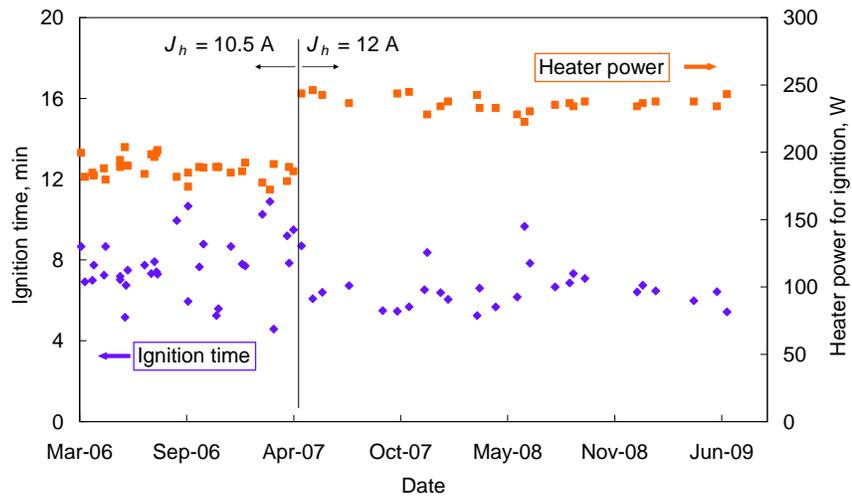
The heating time required for ignition is an indicator of the cathode's condition. Figure 9 shows ignition time and heater power for the past 50 ignition sequences in the endurance test. The ignition time includes one minute of heater current ramp-up. The heater current was changed from 10.5 to 12 A in April 2007 to prevent cathode overheating during long ignition times. As shown in Fig. 9, ignition time has varied widely, but shows no increasing trend. Average ignition times before and after the heater current was changed are 8 minutes and 6 minutes, respectively. The heater power for ignition has been almost constant since the heater current increase. No signs of cathode degradation can be observed from these ignition characteristics.

Figure 9. Required time and power for ignition in discharge cathode endurance test.

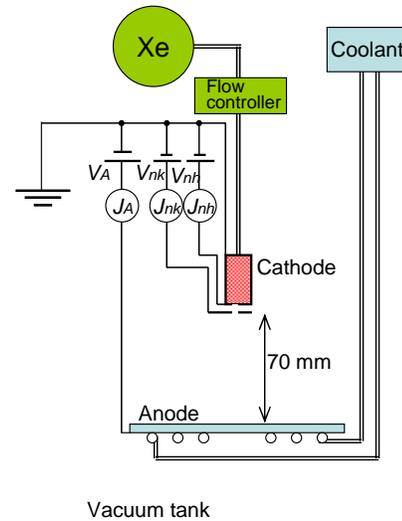
The neutralizer test is being conducted in a triode configuration as shown in Fig. 10. The anode plate is fixed at a distance of 70 mm from the cathode keeper disk. The data acquisition and fail-safe systems are similar to those of the discharge cathode test. The tank pressure during the neutralizer operation has been maintained at approximately 3×10^{-3} Pa for N_2 by a 12,000-l/s cryogenic pump.

Figure 10. Test apparatus for neutralizer cathode endurance test.

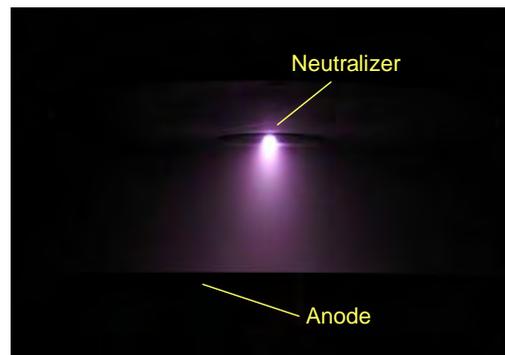
Figure 11. Discharge luminescence in neutralizer cathode endurance test.

Table 2 shows typical operating parameters during the endurance test compared with those of 2.9 A ion beam neutralization operation.¹⁰ The coupling voltage is a potential difference between the neutralizer cathode and the facility ground or ambient plasma during thruster operation and is to be compared with the anode voltage in the endurance test. The table indicates that the endurance test simulates the neutralizer operating conditions during real thruster operation. The test conditions have not been changed except for short-duration measurements of current-voltage characteristics. Figure 11 shows the discharge luminescence of the neutralizer in the typical operating conditions shown in Table 2.

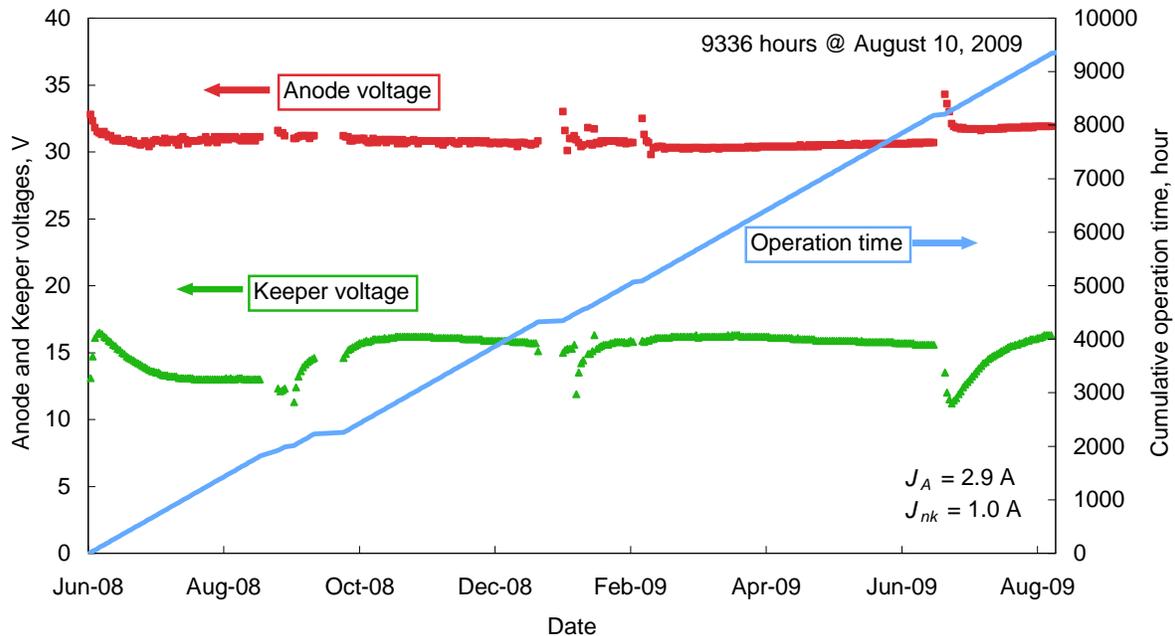
The endurance test of the neutralizer cathode was started in June 2008. The cumulative operation time and variation of voltages during the test are shown in Fig. 12. The test had accumulated 9,300 hours of operation as of August 2009, with a rate of operation of approximately 91% and 13 ignition sequences so far.

Figure 12 indicates that the anode and keeper voltages have been almost constant at approximately 31 V and 16 V, respectively, throughout the test with no gradual increase due to performance deterioration. A notable difference between this neutralizer test and the discharge cathode test is the behavior of the keeper voltage after ignition. In the discharge cathode, both the discharge and keeper voltages stabilize within about 4 days after ignition, while the keeper voltage in the neutralizer test can take a month or more to stabilize. This might imply that the surface condition of the insert changes more slowly after ignition.

Figure 12. Anode and keeper voltages and cumulative operation time in neutralizer cathode endurance test from June 2008 to August 2009.
