Telemicroscopy and Thermography Diagnostic Systems for Monitoring Hall Effect Thrusters

IEPC-2011-129

*Presented at the 32nd International Electric Propulsion Conference,
Wiesbaden • Germany
September 11 – 15, 2011*

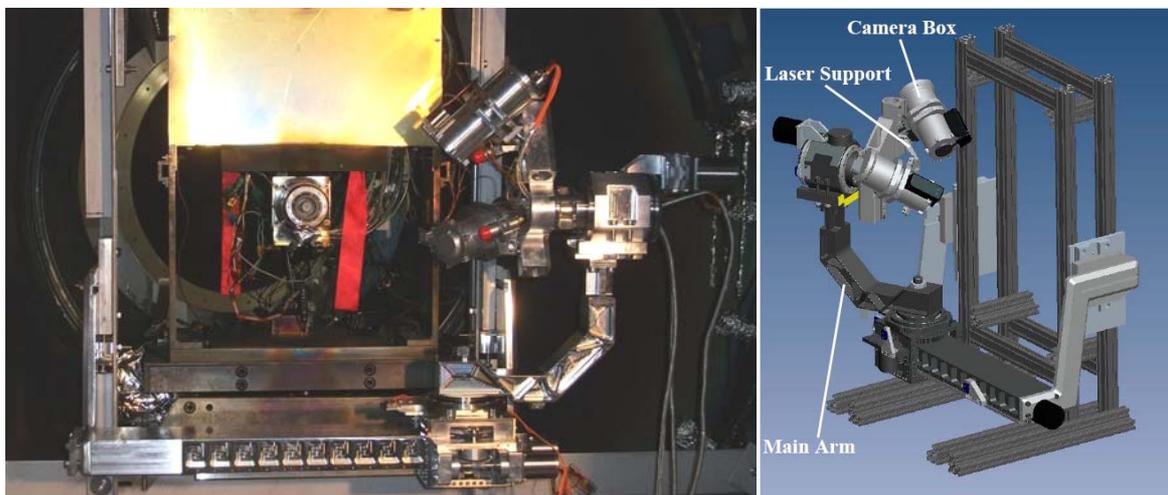
The telemicroscopy system (fig. 1) consists of a moving arm carrying an optical head with two cameras (to acquire images of the ceramic channel profile) and two lasers (to illuminate the edges of the ceramic channel). The diagnostics is non-intrusive and it can be installed inside the vacuum chamber. This allows measuring the erosion of the acceleration channel with no need of opening the facility, thus saving a great deal of time (and costs) when multiple measurements have to be taken. The supporting structure includes a translational platform on which a rotational stage is mounted. Both mechanisms serve to position the optical system out of range of the ion beam plume during thruster firing (parking position). The translation stage and the rotation stage are controlled by vacuum compatible stepper motors. Four microswitches are placed at the operating and parking position of the diagnostics to ensure accurate alignment of the optical head with the target.

Fig. 1: Telemicroscopy system in HET configuration

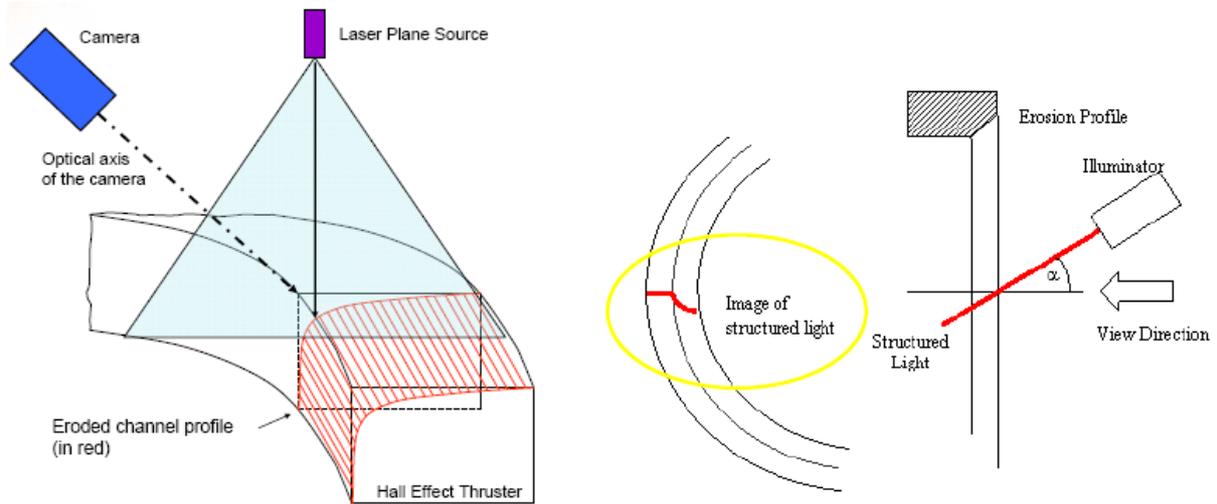
The erosion is measured through a 3D reconstruction of the channel profile. Reconstructing of the profile is performed starting from the images acquired by the cameras. Such images show the projection of a laser line on the channel edges (that is the reason why there are two lasers and two cameras; one is for the inner wall of the channel, the other for the outer wall). The variation of the channel shape can be obtained by observing how the shape of the laser line changes in time when the channel starts to be eroded (see fig.2).

Fig. 2: Working principle of the telemicroscopy diagnostic system for 3D image reconstruction

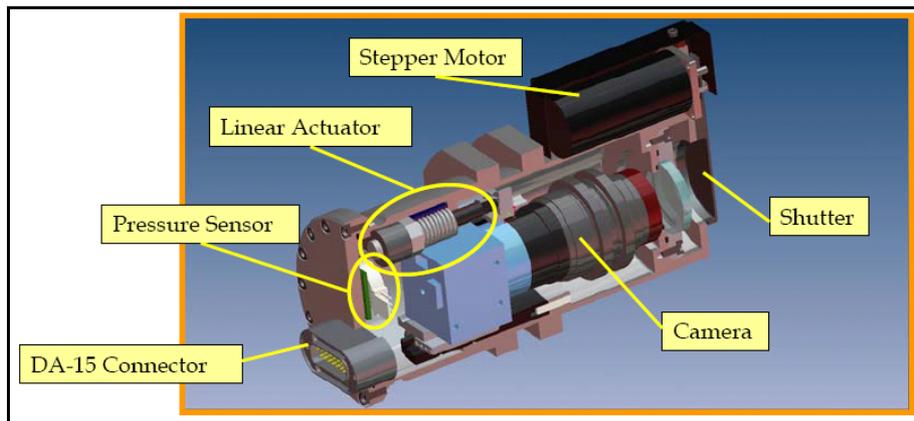
Each camera is protected by a steel enclosure, hosting a pressure sensor, the focus mechanism and the lens assembly as well. The cylindrical boxes provide suitable operation conditions and screen the cameras from sputtering during firing. A DA15M feedthrough for the electrical connections is placed on the rear flange of the box. Each lens is protected by a shutter that is actuated by a small stepper motor. The focus mechanism is operated by a linear actuator which moves the camera back and forth in order to obtain optimal image quality. A scheme of a camera box is represented in fig. 3.

Fig. 3: Detail of the camera box

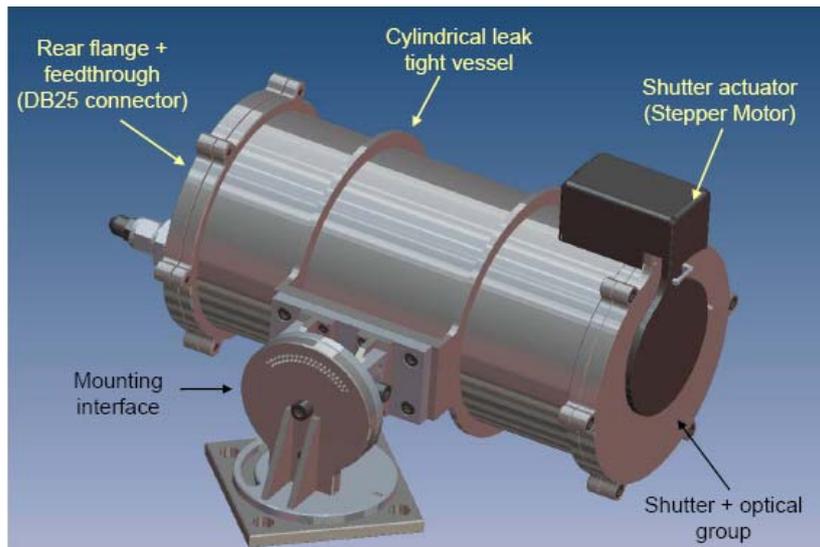
A cylindrical metal box (fig. 4) encloses the IR camera and a pressure sensor to ensure proper operation conditions, as the camera is not vacuum compatible. A DB25M connector for power supply and signal input and output is mounted on the rear flange of the protecting box. Inside the box (fig. 5), a brushed electric motor controls the focusing of the camera lens. The focus has to be regulated only at the start of the testing phase since the distance between the camera and the thruster is constant throughout the test. An aluminium shutter, operated by a UHV-compatible stepper motor, protects the germanium IR window during thruster firing. Two heaters can be installed inside the box in case the thermography system is operated in thermo-vacuum conditions.

Fig. 4: IR Camera box – external view

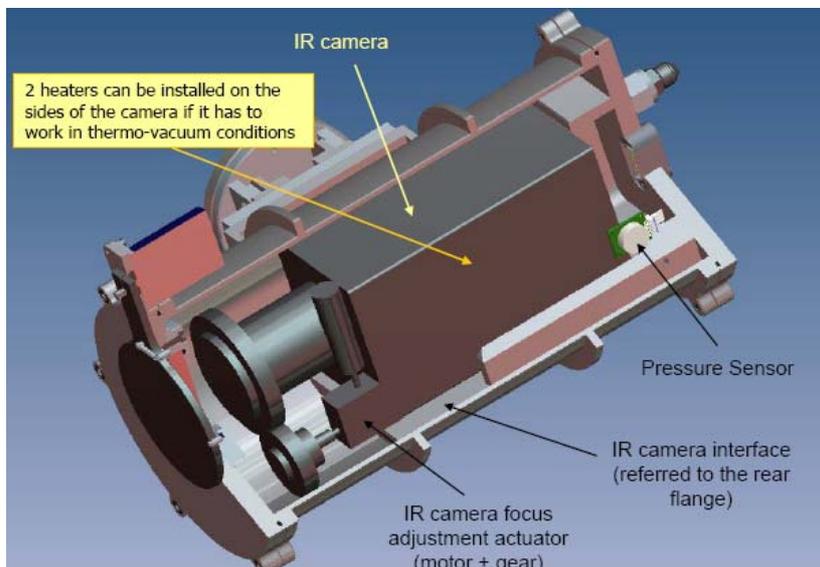
Fig. 5: IR Camera box – internal view

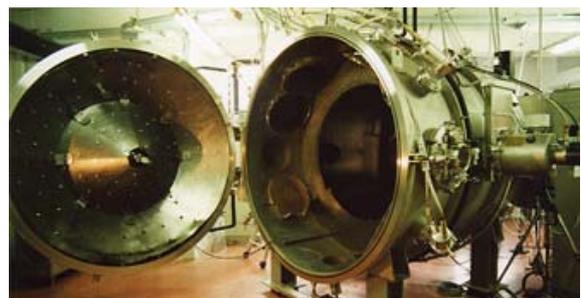
The IV-4 facility consists of two vessels built out of austenitic stainless steel AISI 316 L with a low permeability ($\mu_r < 1.06$). The Main Chamber serves as the beam expansion volume and is connected to the smaller Service Chamber through a gate valve, which can separate the thruster setup from the main chamber in case of emergency or maintenance operations. The dimensions of the chamber are reported in Table 1.

Fig. 6: Alta's IV-4 vacuum facility

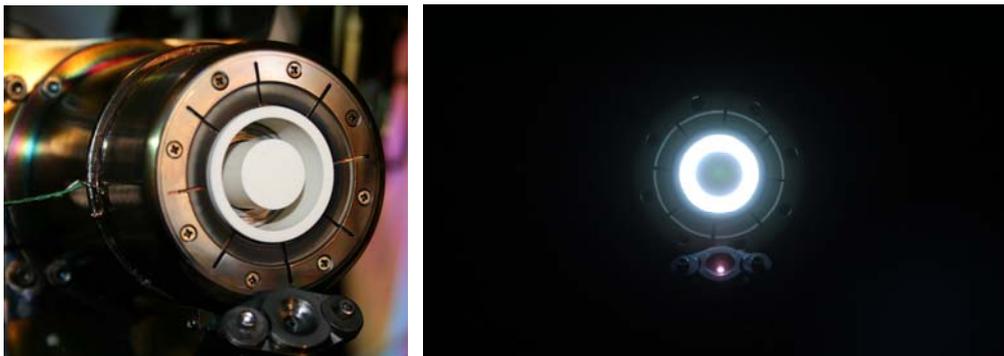
The HT-100 is an SPT type of Hall thruster entirely developed by Alta and operating with a nominal power of 100 W. The thruster has been operated at a higher power level (between 150 and 160 W where feasible) in order to enhance the erosion phenomenon. The performance specifications of the test thruster are displayed in Table 2.

Fig. 7: Alta's HT-100 mini Hall thruster

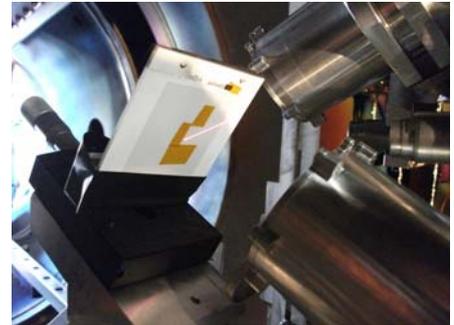
The Telemicroscopy system has been calibrated to acquire the erosion data relative to a HT-100 Hall Effect Thruster. The system calibration is necessary to define the exact position of the laser plane with respect to the camera and to set the focusing parameters of the camera. Fig. 8 shows the target grid that has been employed to calibrate the system, here mounted on a micrometric translation stage.

Fig. 8: Telemicroscopy system calibration

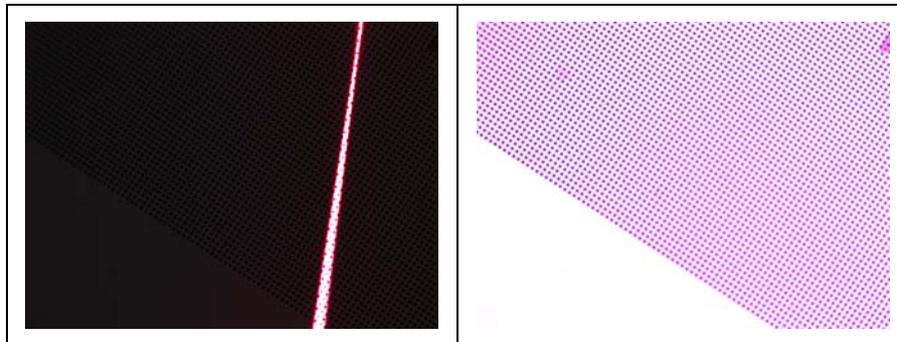
To calibrate the system, five pairs of images are taken. Each pair includes an illuminated picture of solely the target grid and a darker picture of the grid marked by the laser light (see fig. 9). After each acquisition of a pair of images, the target grid is shifted away from the camera by 0.5 mm. From these images the position of the plane of the laser line with respect to the camera is obtained.

Fig. 9: Grid images for system calibration – dark grid with the laser turned on (left), illuminated grid (right)

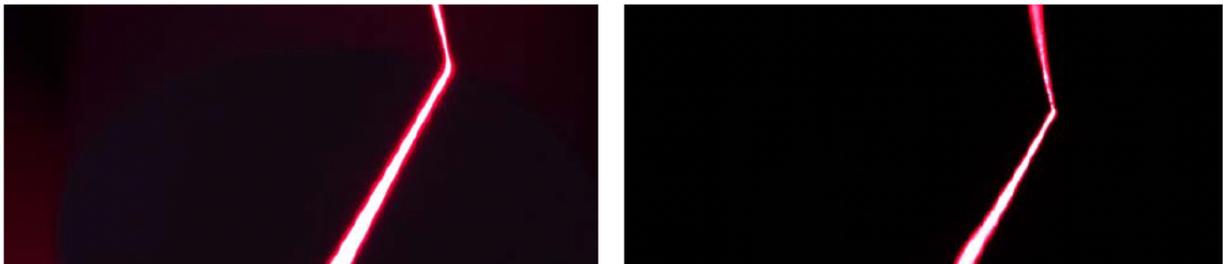
Images of the laser line projected on the inner edge of a BN channel after 450 hrs of operation are presented Fig. 11 in These two pictures are relative to the northern azimuthal section of the thruster and they clearly show the lowering of the inner edge (thus the shrinking of the inner ceramic radius) due to erosion. Channel profiles (up to 6-7 mm inwards from the tip) have then been reconstructed via software for all the four sections investigated and are displayed in Fig. 12. Fig. 13 shows the BN insulator after it has been removed from the thruster: backsputtered graphite has covered its entire surface making it dark grey.

Fig. 11: Laser light projected on the inner edge of BN channel – at the beginning of life (left), after 450h (right)

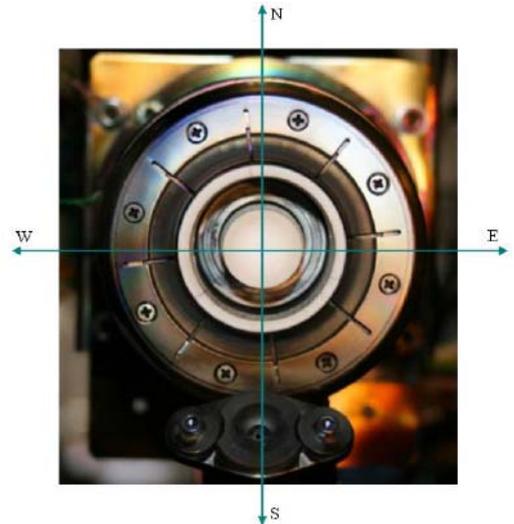
Fig. 10: Four azimuthal sections where the erosion is measured (North-East-South-West)

Since the diagnostic system has the capability of capturing the erosion on different azimuthal sections of a target thruster, for each channel the erosion has been measured on four azimuthal stations shifted of 90° (see Fig. 10) and called North, East, West and South for the sake of simplicity. This multiple measurement provides meaningful information about the axial symmetry of the erosion pattern.

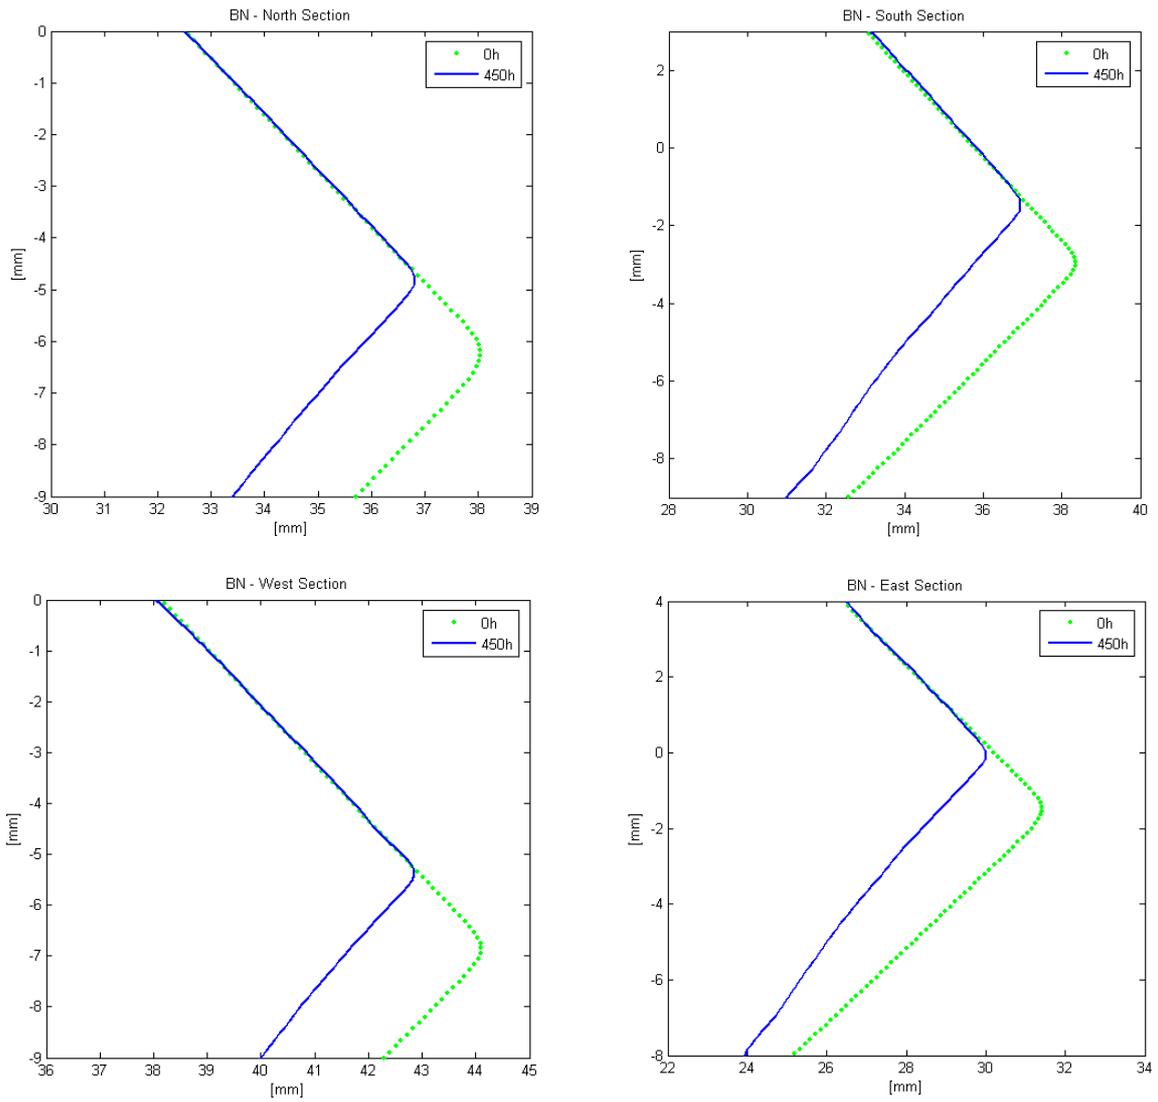
Fig. 12: Reconstruction of BN channel profiles at four different azimuthal positions

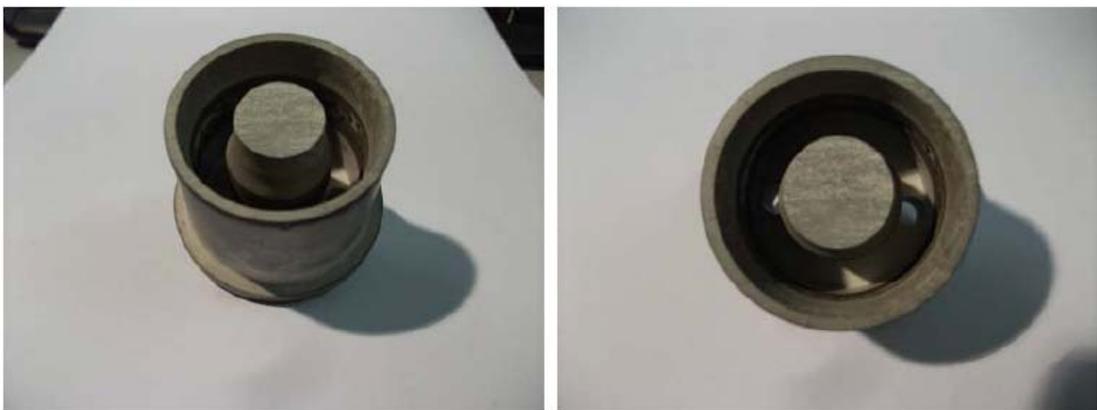
Fig. 13: BN ceramic channel after 450 hrs of operation

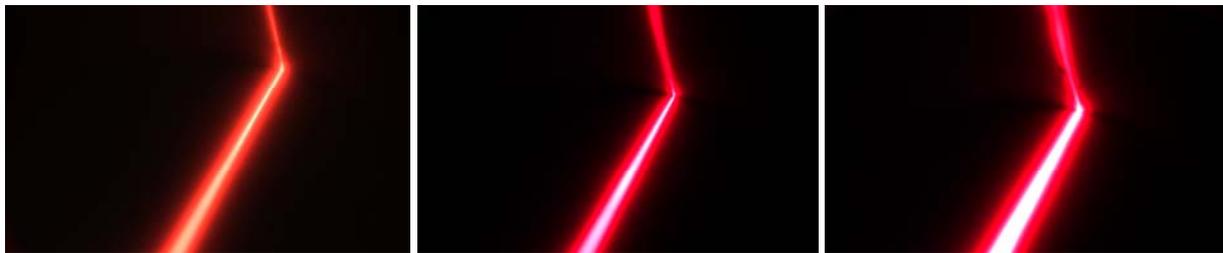
To evaluate the insulator deterioration, pictures have been taken at BOL and after 35 and 70 hours of firing at a power level of 160 W. Fig. 14 shows the acquired images of the channel exit marked by the laser. Fig. 15 shows the profile reconstruction from which the erosion can be immediately determined. After 70 hrs, ceramic erosion is 0.78 mm at the channel tip.

Fig. 14: Camera images of Macor channel inner profile at BOL (left) and after 35h (center) and 70h of operation (right)

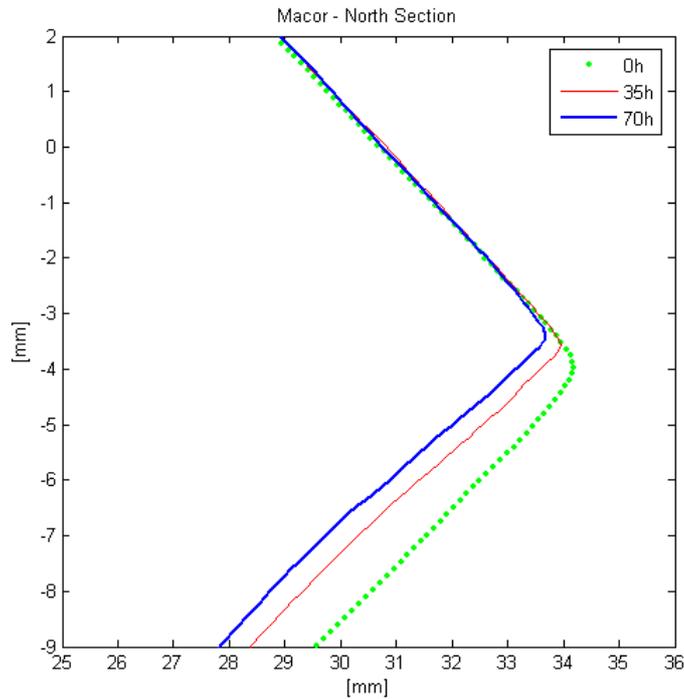
Fig. 15: Reconstruction of eroded profile for HT-100 thruster firing with Macor insulator

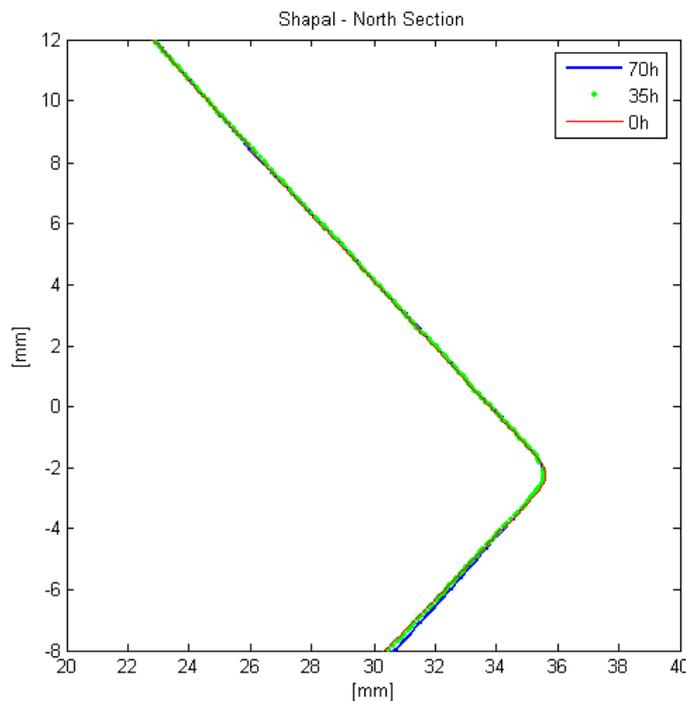
Again, images have been taken before thruster operation and after 35 and 70 hours of firing with a power input of 110 W. A profile reconstruction is shown in Fig. 16. The difference between the profile before the beginning of thruster operation and the profile after 70 hours of testing, is hardly noticeable. After a firing period of 70 hours, 0.10 mm of insulator have been eroded at the channel tip. This is a significantly lower value than the one found for Macor and Boron Nitride. One of the reasons of this behavior is connected with Shapal high thermal conductivity. Since Shapal is a good thermal conductor, when it is used as a channel insulator it is not possible to operate the thruster at a power exceeding 100-110W in order not to overheat other parts of the thruster assembly. Working at a lower power (and then at a lower applied potential) the erosion turns out to be greatly reduced.

Fig. 16: Reconstruction of Shapal eroded profile

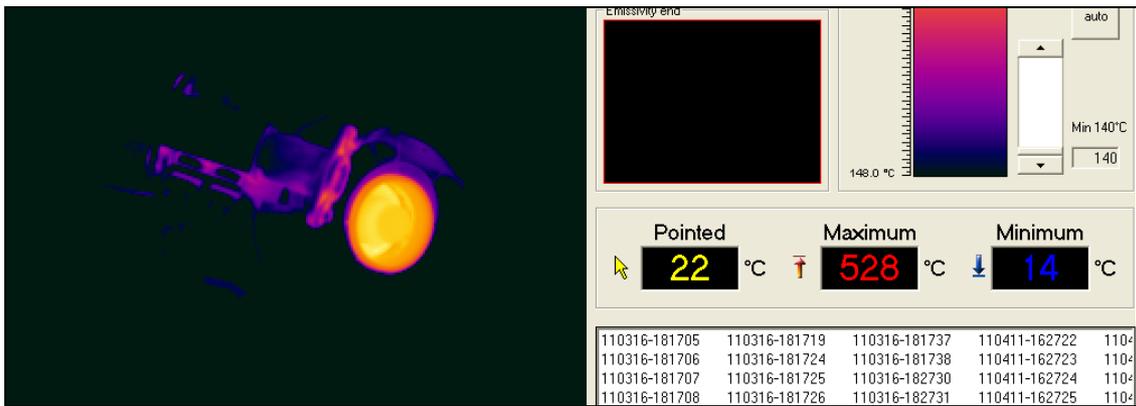
Fig. 17: Boron Nitride ceramic, steady-state, power =160W – Max channel temperature = 528°C

Here follows a series of pictures displaying the temperature distribution for the three different channel-wall materials that have been tested: BN, Macor and Shapal. All the pictures have been taken at the thermal steady state. The power level is not the same everywhere, because it was not possible to operate the Shapal channel at the same power of the others due to thermal restrictions (Shapal is a good thermal conductor and, as a consequence, the thruster supporting structure becomes too hot if the operative power is raised over a threshold level).

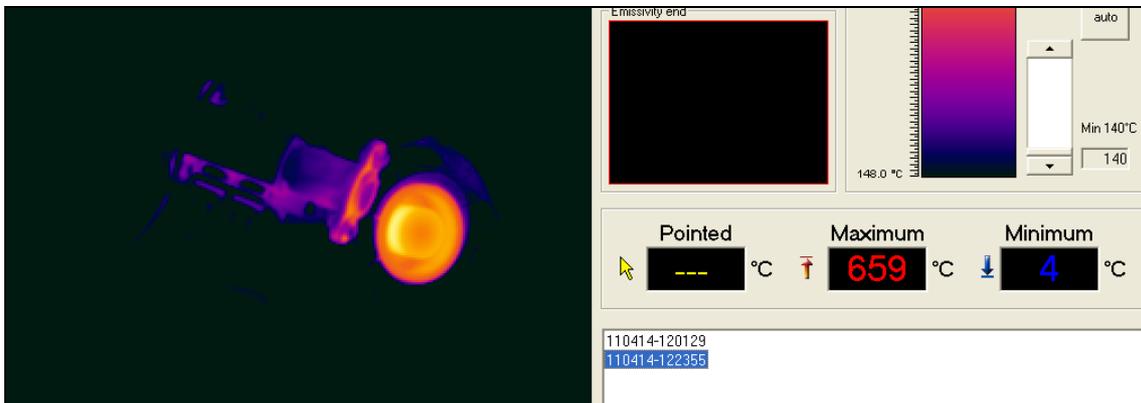
Fig. 18: Macor ceramic, steady-state, power=160W – Max channel temperature = 659°C

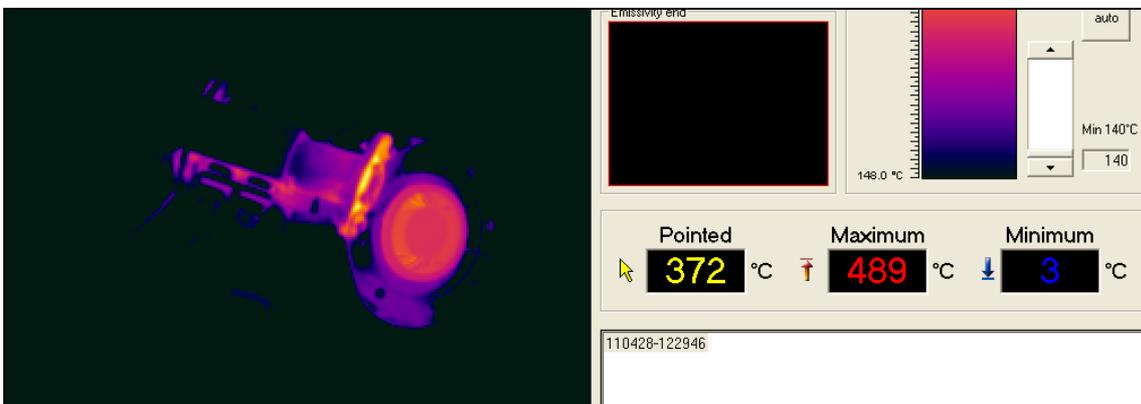
Fig. 19: Shapal ceramic, steady-state, power=110W – Max channel temperature = 372°C

Shapal, being the best thermal conductor among the three materials tested, shows a peak temperature which is considerably lower than the other two (although also the operating power level is lower). On the contrary with Macor, which is an excellent thermal insulator, the heat is trapped in the ceramic walls and the peak temperature exceeds the one reached using Boron Nitride by more than 100°C. These measurements confirm that BN is probably the best choice for this application, since it is the best trade-off between a strong thermal insulator (which prevents the other parts of the thruster from an excessive heating, but leads to a higher channel temperature) and a poor thermal insulator (which does not protect the rest of the thruster, but significantly decreases the peak temperature at the channel tip).

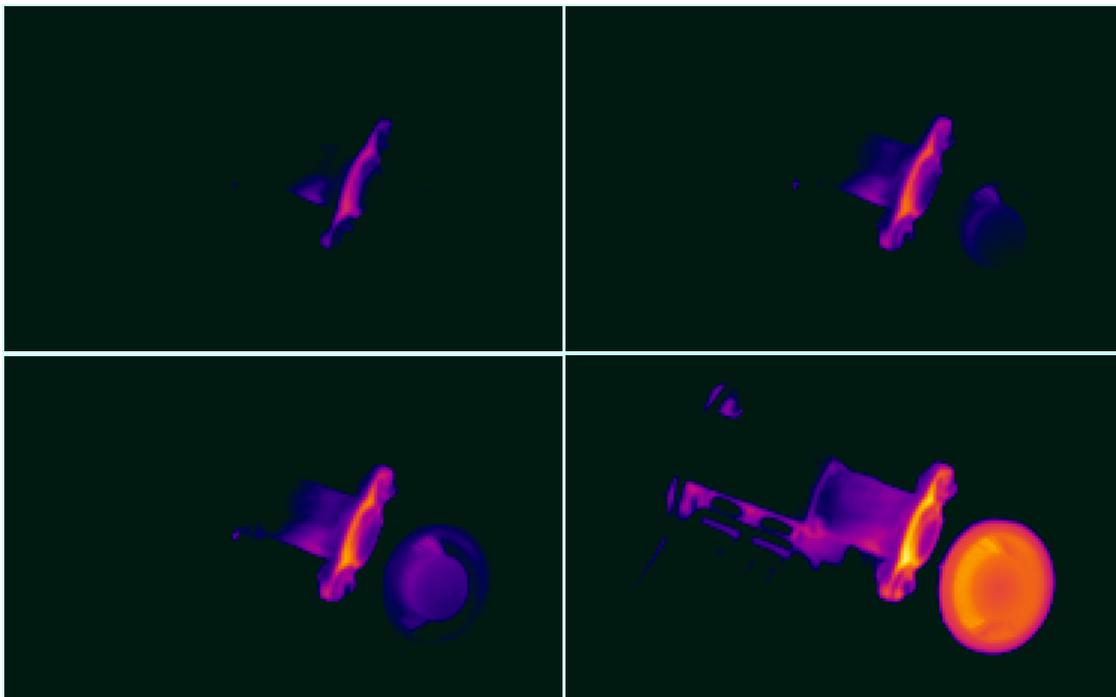
Several pictures taken at different instants are reported here for Alta’s HT-100 thruster operated with a Macor ceramic channel (see Fig. 20) and fed at a power level of 70W. Stationary conditions have been reached after about 30 minutes, as it can be seen from the diagram in Fig. 21.

Fig. 20: Four successive images of HT-100 taken at different times during the first thirty minutes of operation

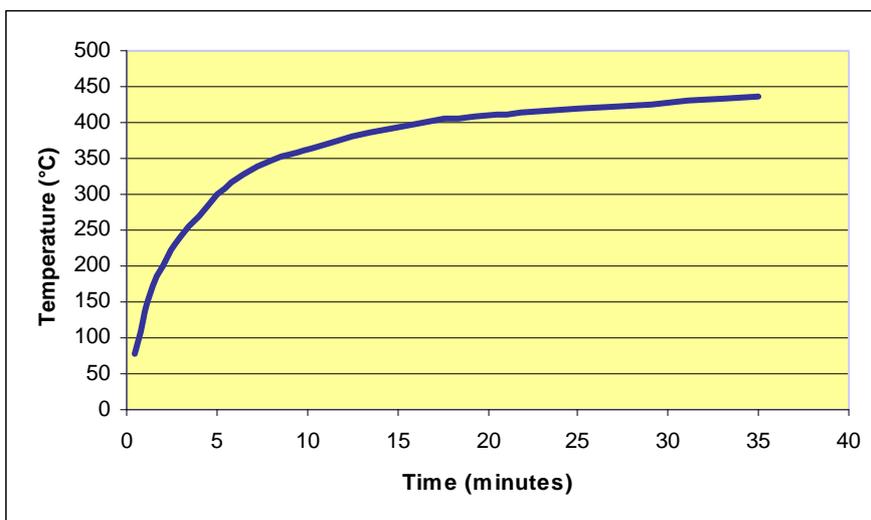
Fig. 21: Macor Max. Temperature vs Time

The maximum temperature reached on the channel walls during the thermal transient test was slightly lower than 450°C. It is interesting to compare this result to the one obtained with the thruster working at a power level of 160W, where the maximum temperature detected in the channel was of 659°C. Halving the power level, the channel temperature has been reduced of more than 200°C.
