# Wear Trends of the HERMeS Thruster as a Function of Throttle Point

IEPC-2017-207

*Presented at the 35th International Electric Propulsion Conference  
Georgia Institute of Technology • Atlanta, Georgia • USA  
October 8 – 12, 2017*

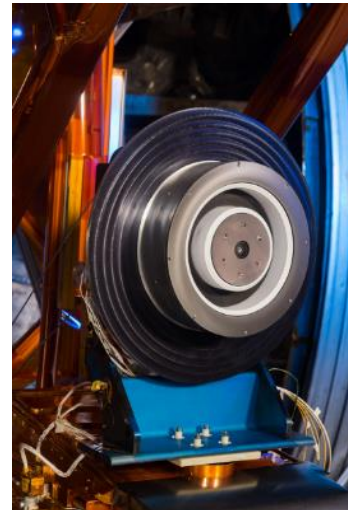
Figure 3. TDU-1 in VF-6 configured for short-duration wear testing.

TDU-1 was operated in Vacuum Facility 6 (VF-6) at GRC. A base pressure of  $9 \cdot 10^{-8}$  Torr (air) was achieved throughout the campaign. However, the pumping speed of VF-6 is roughly half that of VF-5 and TDU-1 operated at higher pressures than did TDU-3 in VF-5 for the same thruster operating condition. VF-6 was modified to accommodate AEPS testing as described in Peterson.<sup>18</sup> This included the fabrication of a thrust stand and assembly of a plasma probe rake identical to the one used in VF-5. An improved data acquisition and recording software suite was developed for VF-6 testing and then incorporated at VF-5. Figure 3 shows TDU-1 in VF-6 during the test campaign.

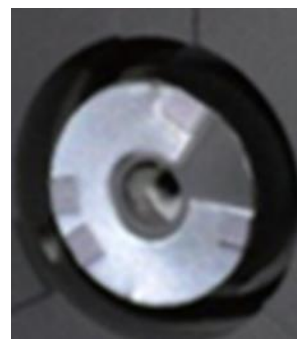
Figure 4 shows a Mo mask that was used to characterize the erosion of the keeper electrode. The mask incorporated a notch that exposed the underlying graphite surface and an orifice that was significantly larger than the keeper orifice to minimize the impact of the mask on the keeper's operating characteristics. The mask was replaced after each test and the notch was clocked to expose a different segment of the keeper electrode. The mask was held in place by a tantalum sleeve that was spot-welded to the Mo mask and friction fit around the outer diameter of the keeper tube. The tabs of the Ta sleeve that folded over the Mo mask and provided the point of attachment also provided unexposed surfaces on the Mo mask for measurement reference.

**Figure 4. Mo mask on keeper electrode.**
