# Ageing Effects of a Hall Thruster Plume on Solar Array Performance and ESD Susceptibility

IEPC-2017-493

*Presented at the 35th International Electric Propulsion Conference  
Georgia Institute of Technology • Atlanta, Georgia • USA  
October 8 – 12, 2017*

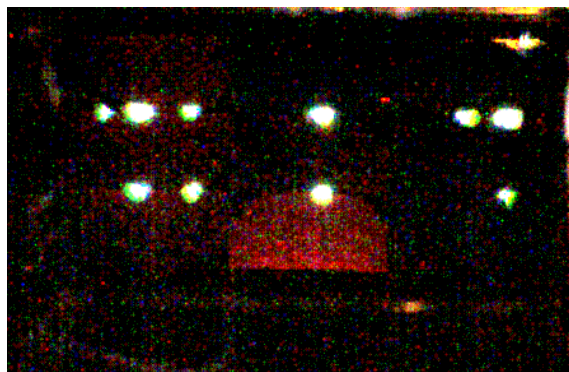
**Figure 11. Composite Image of All EOL Inverted Gradient Events.** This image shows a per-pixel average of all high speed camera frames taken during end of life inverted gradient exposure.

emanating from the vertical edges of each cell. The vertical lines appear to follow the path of the incident ions, projected onto the surface.

The origin of this pattern formation is not clear but it is not without precedent. A number of studies have suggested ion erosion can produce periodic grooves and other patterns in surfaces under certain conditions [16-19]. If there is even the slightest pattern to the surface etching, streamers will tend to follow it.

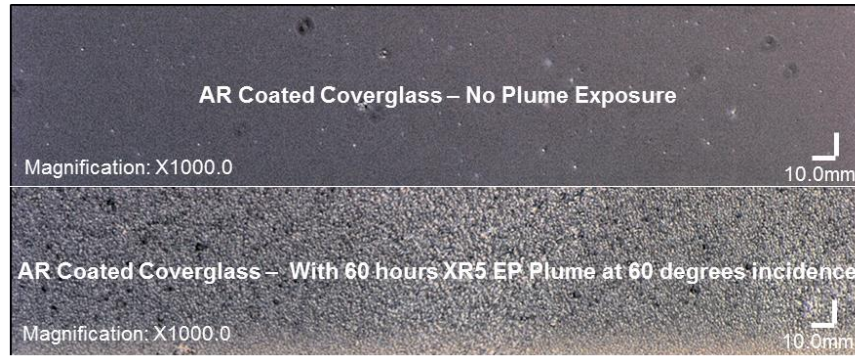
**Figure 16. Magnified BOL & EOL Coverglass Images.** *Pristine AR Coated Coverglass (top) compared to a coverglass with the AR coating removed and textured by the EP plume (bottom).*

This is a very significant and unexpected result that may be explained by the very small scale surface texturing created by the Xenon ion plume erosion. Figure 16 shows a comparison at 1,000X magnification under a Keyence VHX-5000 microscope between the micro-scale texturing in the AR coated coverglass exposed to the EP plume and the smooth surface of the AR coated coverglass not exposed to the EP plume. It is hypothesized that the loss of the  $\text{MgF}_2$  AR coating due to the EP plume (and corresponding loss in cell current) may be off-set by the AR properties of the fine-scale surface structure created by the EP plume. Surface structures with dimensions on the order of the wavelength of visible light ( $\sim 0.5\mu\text{m}$ ) have known anti-reflective properties [20]. If further research confirms this result then the power degradation due to EP plume exposure may be less than expected due to this phenomenon.
