The 25 cm XIPS[®] Life Test and Post-Test Analysis

IEPC-2009-161

William G. Tighe*, Kuei-Ru Chien†, Zeke Solis‡, and Rafael Spears§
L-3 Communications Electron Technologies, Inc., Torrance, CA, 90505

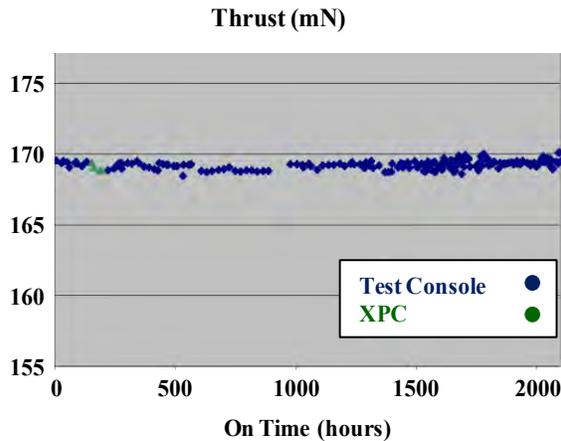
Figure 4. High Power Trend Plot showing Thrust.

Examples of High Power Trend Plots and Functional Test Plots are shown in Figs. 4 to 7. The Thrust and Isp were very stable and well within specification throughout the High Power phase of the Life Test. Due to Accel grid

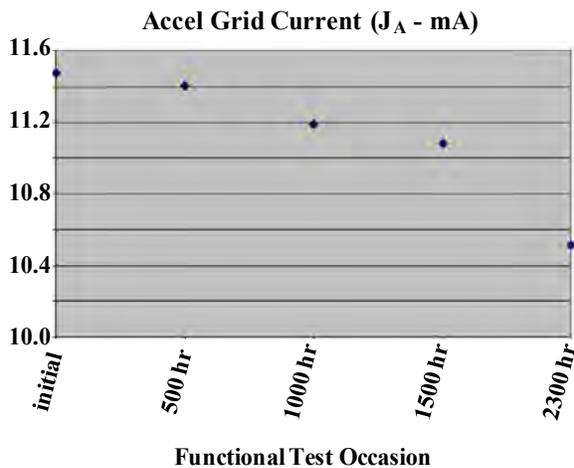
Figure 6. High Power Functional Test Results. Accel Current Measurements

aperture diameter enlargement, the Accel grid current decreased during the High-Power phase of testing, and toward the end of this test phase, the Accel voltage had to be increased in order to prevent excess recycles at start up.

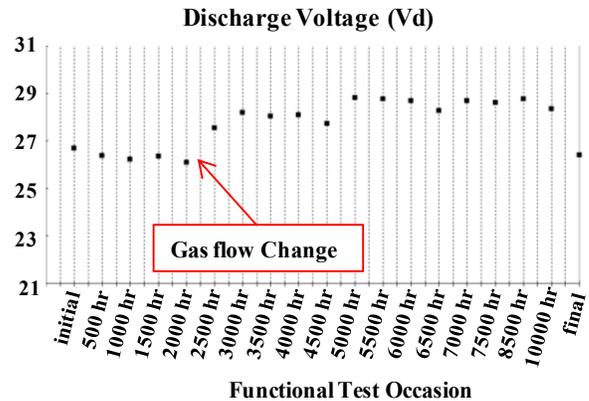
Figure 11. Low Power Functional Test Results showing the Discharge Voltage.

There were a total of 19 functional tests performed during the low-power phase of the life test. All thruster parameters were within specification during all nineteen functional tests. Examples of Trend Plots and Functional Test Plots are shown in Figs. 8 to 11. The intentional change of the gas flow is indicated. The reason for this was to increase the discharge voltage to a “worst case” condition for wear of the Screen grid. In addition the steady increase in the Neutralizer Coupling Voltage (V_g) and the sudden increase in V_g on the last Functional Test Occasion was noted and felt to be due to erosion of the NCA Keeper and Orifice Plate.

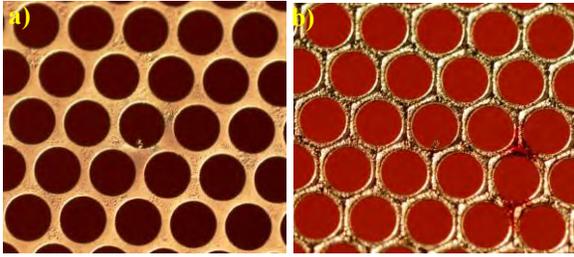
Close-up photographs of a region of the Screen grid that contained a small inclusion in a single aperture are shown in Fig. 15. Except for the inclusion, the photograph is representative of the grid surface.

The presence of hexagonal grooves surrounding the apertures is clearly indicated on the upstream face of the grid. This is probably due to direct erosion of this surface from plasma ions and is similar to the "pits & grooves" erosion observed with the NSTAR thruster[7]. The downstream face is smooth.

Figure 15. Close-up images of downstream (a) and upstream (b) faces of the Q2 Screen Grid

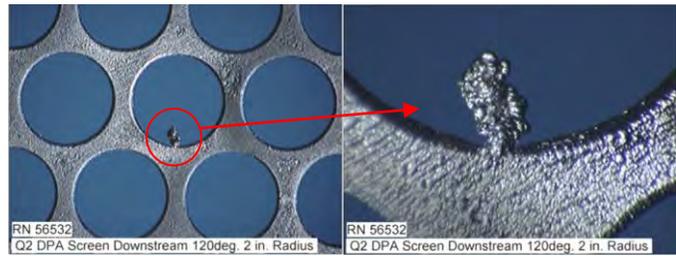
Figure 16. High resolution image of the downstream face of the Q2 Screen grid showing the inclusion.

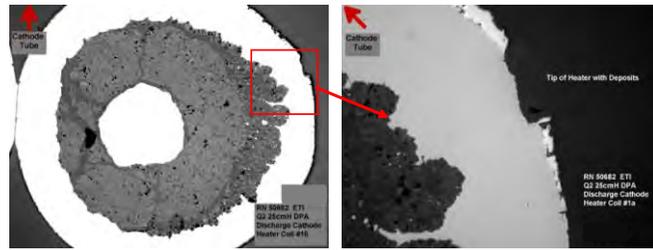
The metallographic images show changes but no dangerous deterioration of the heater. There was some formation of tantalates and migration of tantalum into the MgO. A single coil (shown in Fig. 25) at the output end showed intrusion of the MgO into the outer conductor. While

there was some loss of wall material, there was no danger of failure.

Figure 25. Metallographic image of one coil of the cross-sectioned DCA heater.

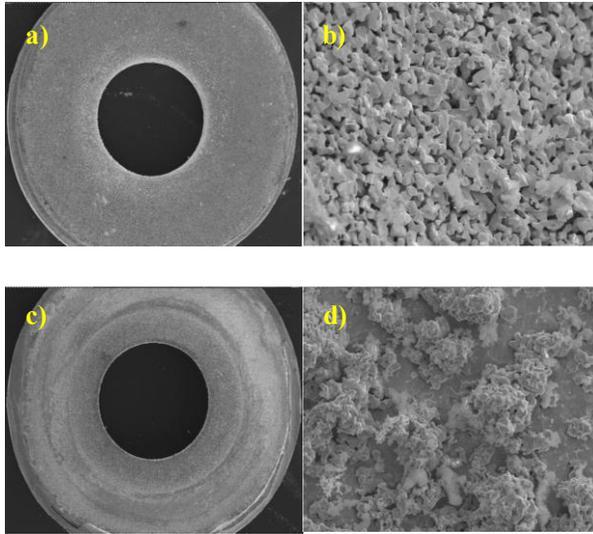
The Mo:Re Discharge Cathode Orifice Plate was then cut off from the Cathode Tube and analyzed using SEM/EDS. An overview and a higher magnification SEM image taken near the aperture on the front and rear faces of the Orifice Plate are shown in Fig. 28. Plasma erosion of the downstream (front) surface is apparent. The EDS spectrum of the downstream (front) surface is apparent. The EDS spectrum showed only rhenium and no molybdenum. The lack of molybdenum is presumably due to a higher sputter rate for molybdenum in this environment that has removed it from the surface. The presence of impregnant elements (barium and calcium) was noted and would be expected in this region of the cathode. The EDS spectrum and an elemental map (not shown) taken on the rear (upstream) face of the Orifice Plate showed the Mo:Re base material as well as the locations of barium and calcium on the surface.

Figure 28. SEM images showing overview and high magnification images of the front (a & b) and the rear (c & d) of the DCA Orifice

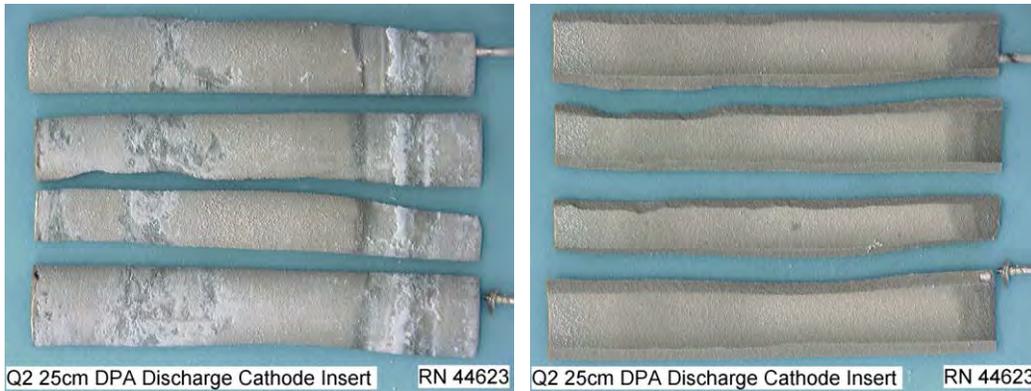
Optical photographs are shown in Fig. 30. They show a white deposit on the outside surfaces consisting of bands, especially in the colder upstream region. The inside surface also consists of several bands or regions. In the forward, downstream region there is band of an apparent, white particulate residue. This residue becomes less dense in the central region. In the colder upstream region there are two distinct bands that have progressively darker appearance.

Figure 30. Photographs of the outer (a) and inner (b) sides of the Q2 DCA hollow cathode insert after intentional fracturing for DPA. The downstream region is to the left and the upstream to the right.

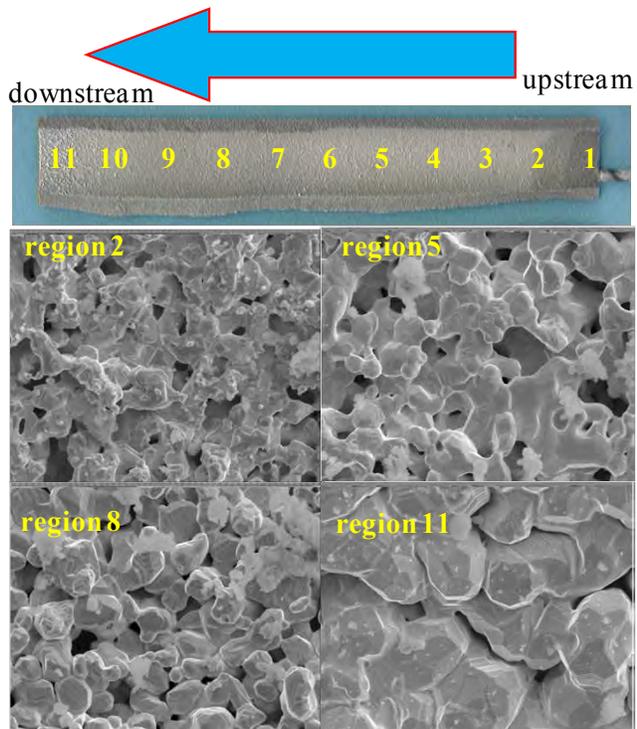
ESCA data was obtained but is not presented here. SEM images (low and high resolution) and EDS spectra were taken at 11 locations along the inner surface of the fragmented insert. The approximate locations are indicated in Fig. 31. The high resolution SEM images showed indications of “blooming” of the impregnant and the formation of tungstates at many locations on the surface. Changes in the morphology of the tungsten matrix from the cold, rear locations (region 2) to the hotter locations near the tip (region 11) can also be seen in Fig. 31.

EDS data taken across the inside diameter of the insert can be summarized as follows. In the upstream location (regions 1 and 2) there is very little heating of the insert either during ignition (with the heater activated) or operation. The SEM photographs in this location show little or no change from a non-operated insert. In the central position (region 4 to 8) heated during ignition and operation but having little or no interaction with the plasma, there is a reduction in the amount of barium. In the downstream location (regions 9 to 11), there is significant depletion of barium and the presence of molybdenum. The molybdenum signal is first detectable around region 7 but is seen to grow from region 9 to 11. This surface sees significant plasma interaction during operation and molybdenum arising from erosion of the orifice plate may have been deposited in the downstream region of the insert.

Figure 31. Regions of inner diameter of Q2 DCA insert that underwent SEM/EDS analysis and SEM images from specified regions.

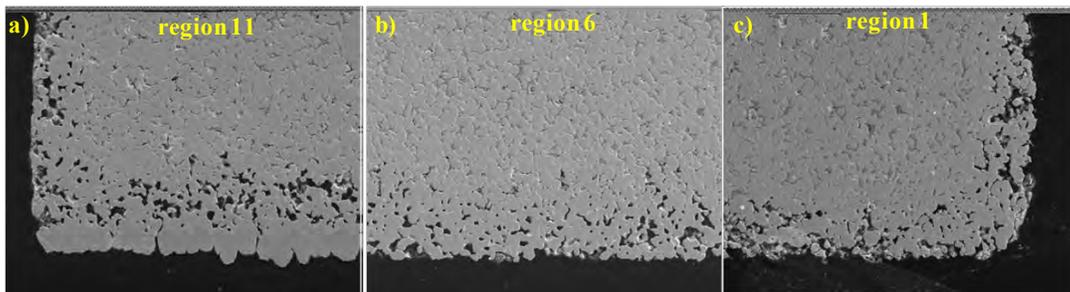
Figure 32. Overview SEM images of the inner diameter region of the cross-sectioned Q2 DCA insert. Images show the downstream (a), central (b) and upstream (c) regions of the insert.

Figure 32 shows overview SEM images of the inner diameter of the insert in 3 locations; the “downstream” location which reaches temperatures >1200 C and undergoes plasma interaction during operation, a middle location which gets hottest during ignition, is significantly cooler during operation and is not expected to interact with the plasma (at least early in life), and the rear “upstream” location which is relatively cool during life and would not be expected to undergo significant changes.

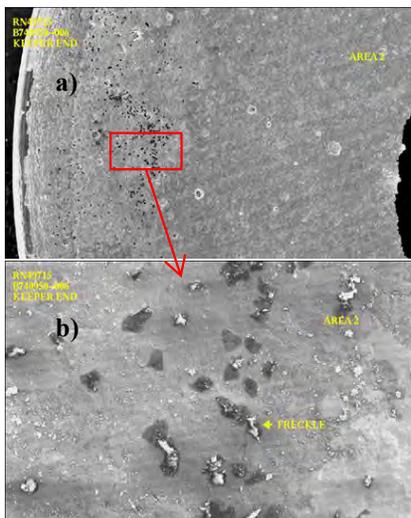
A detailed SEM/EDS analysis was then performed on the front and back sides of the Keeper End Cap. Low and high magnification SEM images taken over 8 areas on the front “downstream” side of the Keeper documented the entire surface and showed the irregular edge of the orifice, the granular nature of the surface and the presence of dark particles. Some of these features can be seen in Fig. 39. EDS data showed the Mo:Re base material. In addition, chlorine, potassium, sodium and the impregnant materials, barium and calcium, were present in the particulate. Aside from the impregnant material, the origin of these elements is unclear.

Figure 39. Low (a) and high (b) magnification SEM images showing presence of particulates on the front face of the Q2 NCA Keeper.

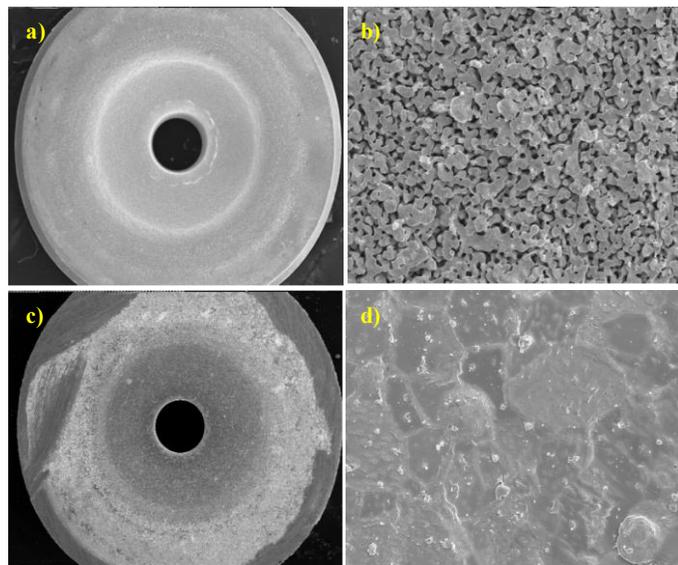
An overview and a higher magnification SEM images taken near the aperture of both the front and the back of the Orifice Plate are shown in Fig. 42. On the front (downstream) surface the plasma eroded surface texture is apparent. As with the DCA Orifice, the EDS analysis showed a strong presence of rhenium and a lack of molybdenum. Unlike the DCA Orifice there was no presence of impregnant elements (barium and calcium) in this region. SEM/EDS analysis of a region on the outer diameter of the front face was similar though the high magnification SEM image showed somewhat different morphology. An elemental map, for a region on the outer diameter of the front face of the Orifice Plate is shown in Fig. 43. The different morphology and the dominant presence of rhenium at this location on this surface are clear.

Optically, the rear (upstream) face of the Orifice Plate had a shiny inner and a dark outer ring. On the inside diameter, the EDS analysis showed only the base materials of molybdenum and rhenium. There was also some indication of the presence of tungsten on the surface. At the outer diameter the SEM image showed the presence of a deposit and the EDS analysis showed

Figure 42. SEM images showing overview and high magnification images of the front (a & b) and rear (c & d) of the NCA Orifice Plate.

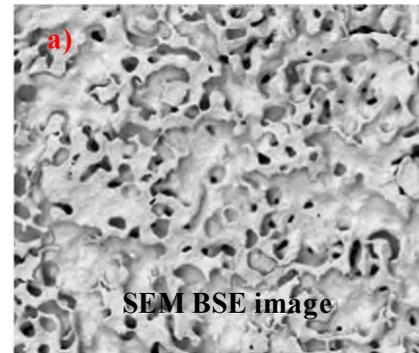
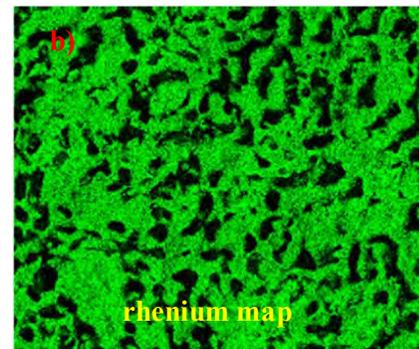
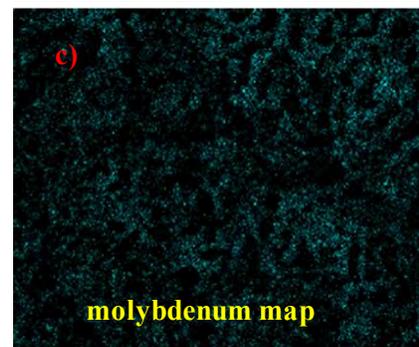
Figure 43. SEM image (a) from the outside radius of the front face of the NCA Orifice Plate and EDS elemental maps (b & c)

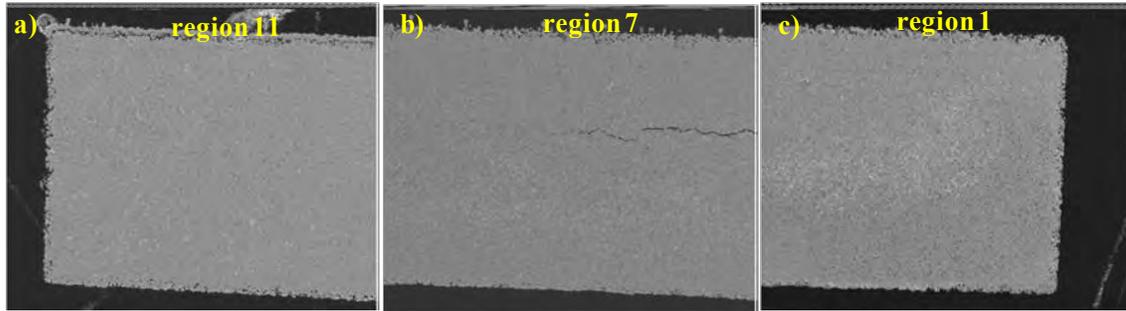
Figure 47 shows overview SEM images of the inner diameter of the insert in 3 locations; the “downstream” location which reaches temperatures of ~ 1150 °C and undergoes plasma interaction during operation, a middle

Figure 47. Overview SEM images of the cross-sectioned Q2 NCA insert. Images show the downstream (a), central (b) and upstream (c) regions of the insert.

location which gets hottest during ignition, is significantly cooler during operation and is not expected to interact with the plasma (at least early in life), and the rear “upstream” location which is relatively cool during life and would not be expected to undergo significant changes.
